Front Service Washer Updates

HOME LAUNDRY HL3-96
LOUISVILLE BUILT "T" MODEL-
HOTPOINT, GE, RCA WASHERS.
LOWER HARNESS KIT

HOME LAUNDRY HL4-96
LOUISVILLE BUILT "T" MODEL-
HOTPOINT, GE, RCA WASHERS.
BLEACH FUNNEL KINKED
March 8, 1996

**HOME LAUNDRY HL5-96
LOUISVILLE BUILT "T" MODEL-
HOTPOINT, GE, RCA WASHERS.
WATER VALVE NOISE**

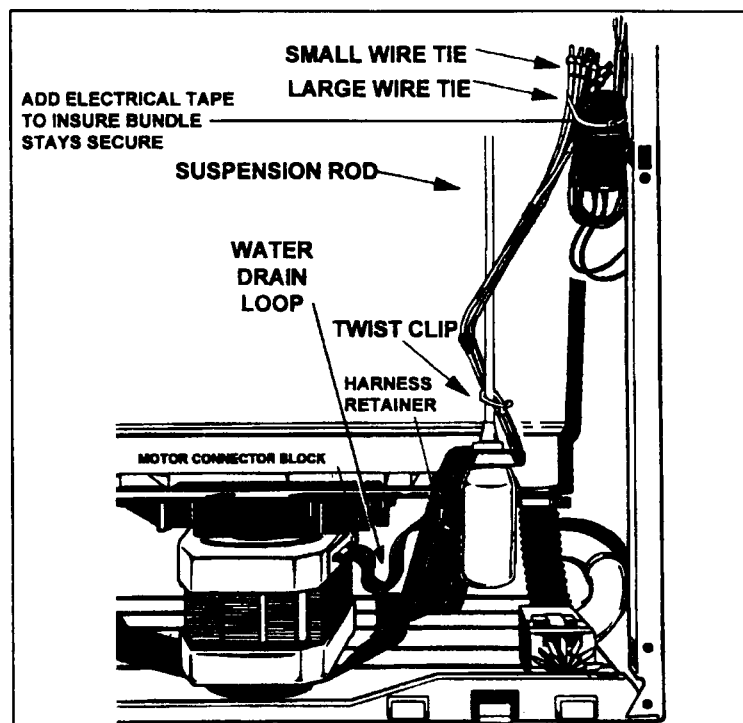
- IMPORTANT!** 1. Find plastic push in harness retainer on new harness section and insert it fully into existing hole in right front *platform leg*. (See illustration for location).
- IMPORTANT!** 2. Plug in motor connector until it is seated, and make sure that the harness forms a loop below the motor connector to prevent water from running down wires and into motor plug.

3. **ROUTE WIRES BEHIND FRONT PLATFORM LEG.** Dress wires upward spiraling between tub and suspension rod, towards capacitor mounted on cabinet flange. (See illustration)

5. Using small wire tie, secure all 14 wires together just below connectors.
6. Position the wire bundle directly behind the capacitor with the wire connectors protruding 2 1/2" above the capacitor top. Secure with the large wire tie to the capacitor. (See illustration)

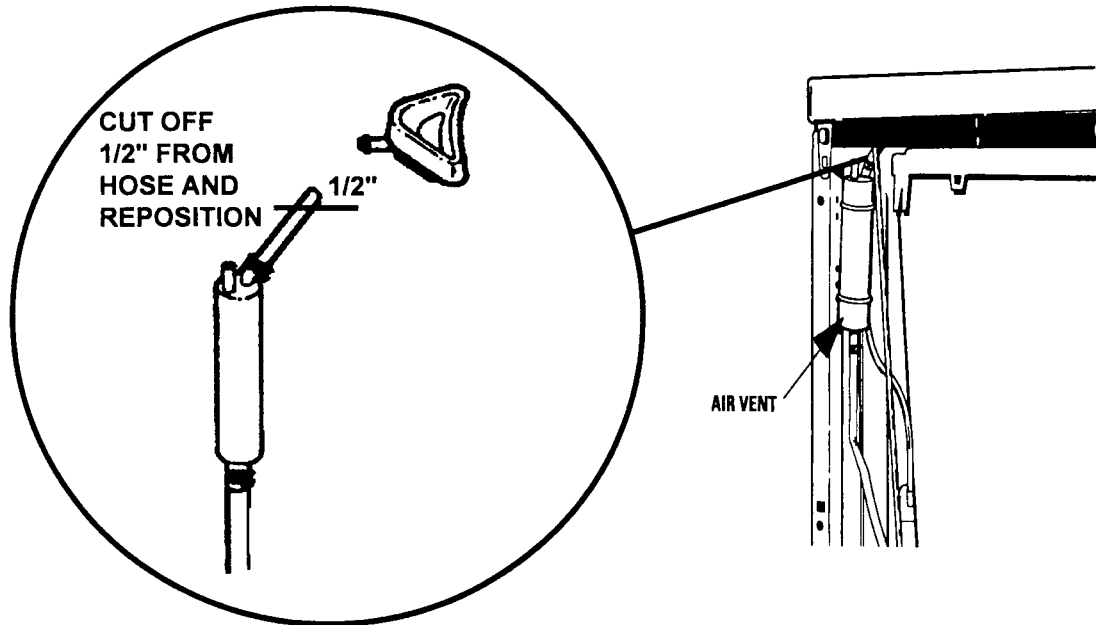
CUSTOMER COMPLAINT BLEACH OVERFLOWS OR WON'T DISPENSE

On some full sized GE, Hotpoint, RCA, and Profile washers the hose on the bleach funnel to the air vent bottle can be kinked when installed at the factory. To eliminate the kink, remove the front panel from the machine, disconnect the hose from the funnel, cut off approximately 1/2" of the hose, reposition the air vent bottle and the hose to eliminate the kink. Caution the customer to only pour bleach into the funnel as fast as the system will allow. Do not pour fast enough to cause the funnel to overflow. Before reinstalling the front panel, bend the outside corners of the motor shield down 1/2" according to illustration below.

BEND CORNERS OF MOTOR SHIELD DOWN ABOUT 1/2"

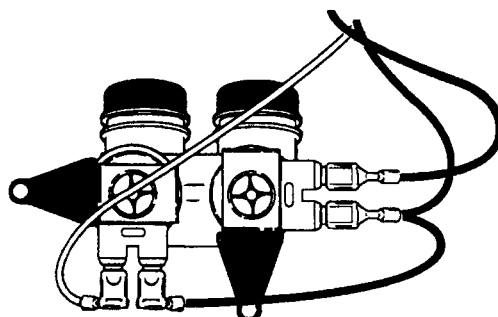
**WH13X0086
WATER VALVE**

To address customer complaints of water valve noise or "squealing, on non-Profile models, replace water valve, and add foam insulator now available from parts (WH46X0360).

**NEW WATER VALVES ARE
QUIETER**

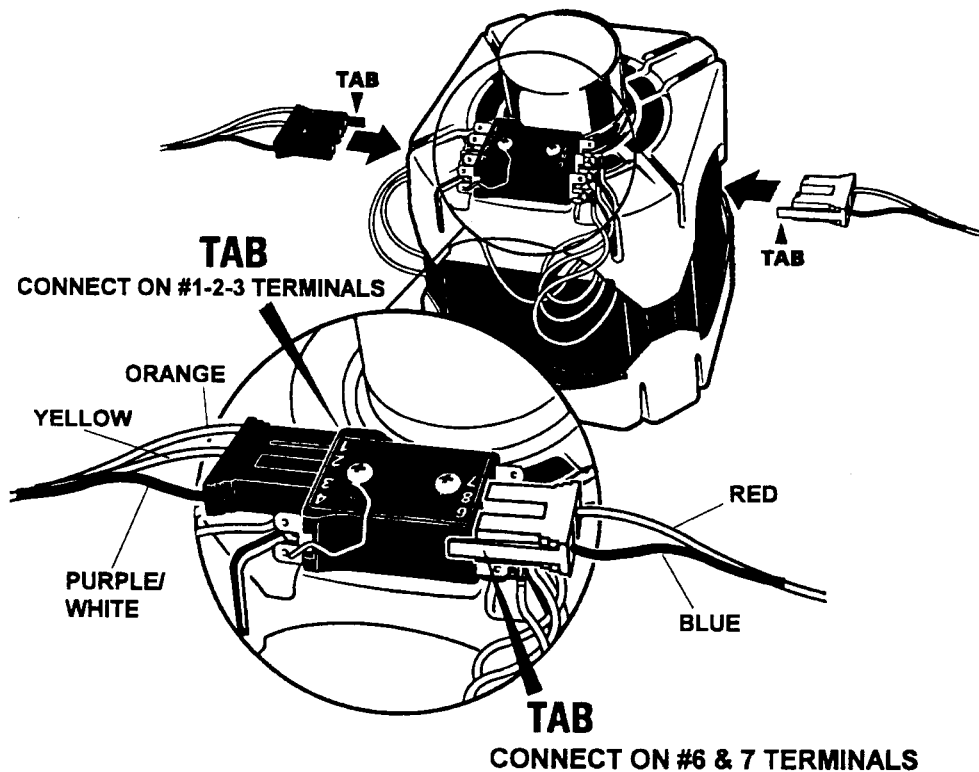
When replacing a single speed "T" model washer motor (WH20X865), the number terminal code on the harness connector block will not match the numbers on the new replacement motor.

2. Ignore the stamped number code on the new motor connector, and instead match the harness blocks by color.
3. See illustration below for correct wiring connections for the new K-Stack motor.

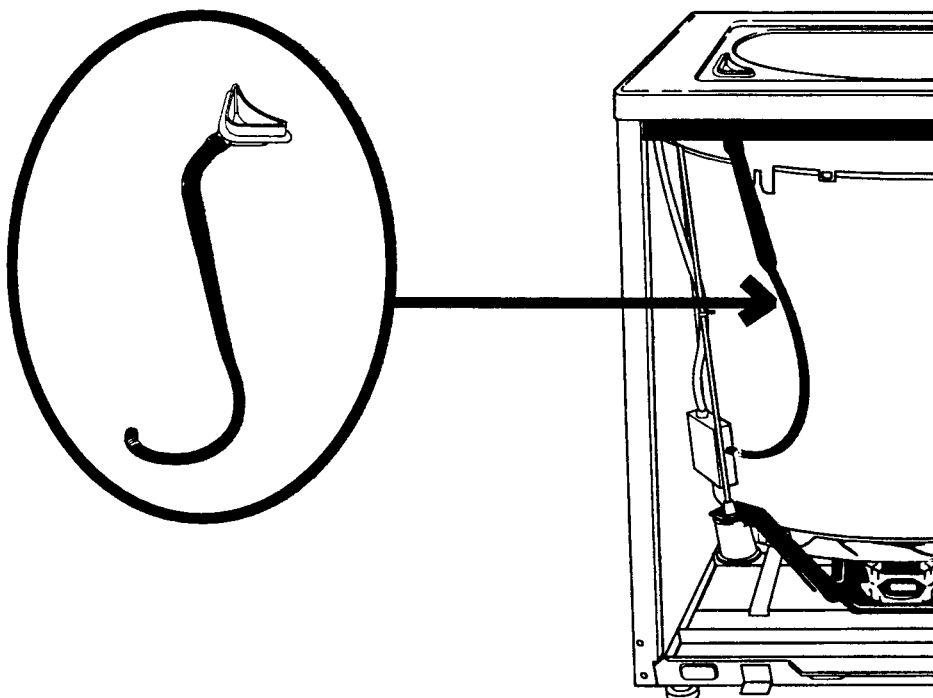
BLEACH DISPENSER KIT WH49X314

On all "T" model Profile, GE, Hotpoint, and RCA washers, the bleach dispensing system has been changed and simplified. The new system consists of only three parts, does not kink, and allows more bleach to flow through the system. This reduces the chance of a customer overfilling and damaging the machine. The new bleach dispenser is available as a kit, Part # **WH49X314**, and will fit all "T" model washers having the bleach dispenser option.

To use the new bleach dispenser system on existing machines remove all of the parts associated with the old system and discard. Install the kit by raising the washer cover, snapping the funnel into the existing hole, and threading the hose down through the rod support. The clamp provided is to seal the connection at the tub. This clamp must be disconnected when removing the cover in the future.

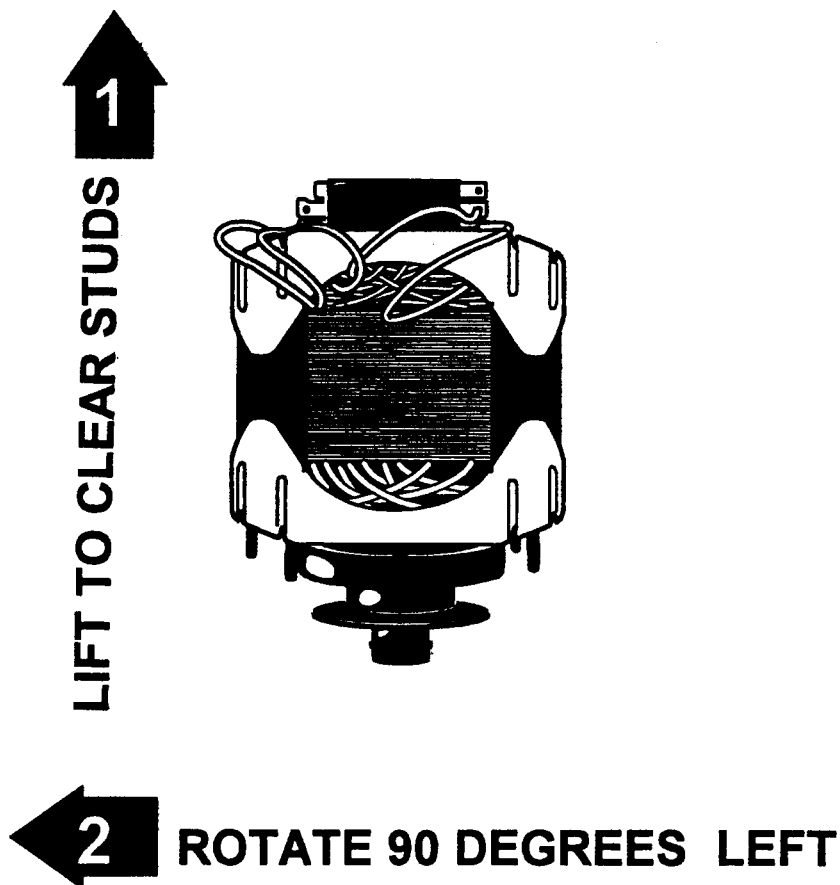
On all "T" model GE, Hotpoint, and RCA washers, the single speed motor stack height was increased, making it necessary to change the motor removal procedure.

If the motor won't tip to the back after you remove the four attaching nuts, the harness, and the belt, lift it enough to clear the studs and rotate it 90 degrees to the left. That will allow the centrifugal switch to clear the motor shield and allow the the motor to be tipped back and pulled foward, clear of the machine.

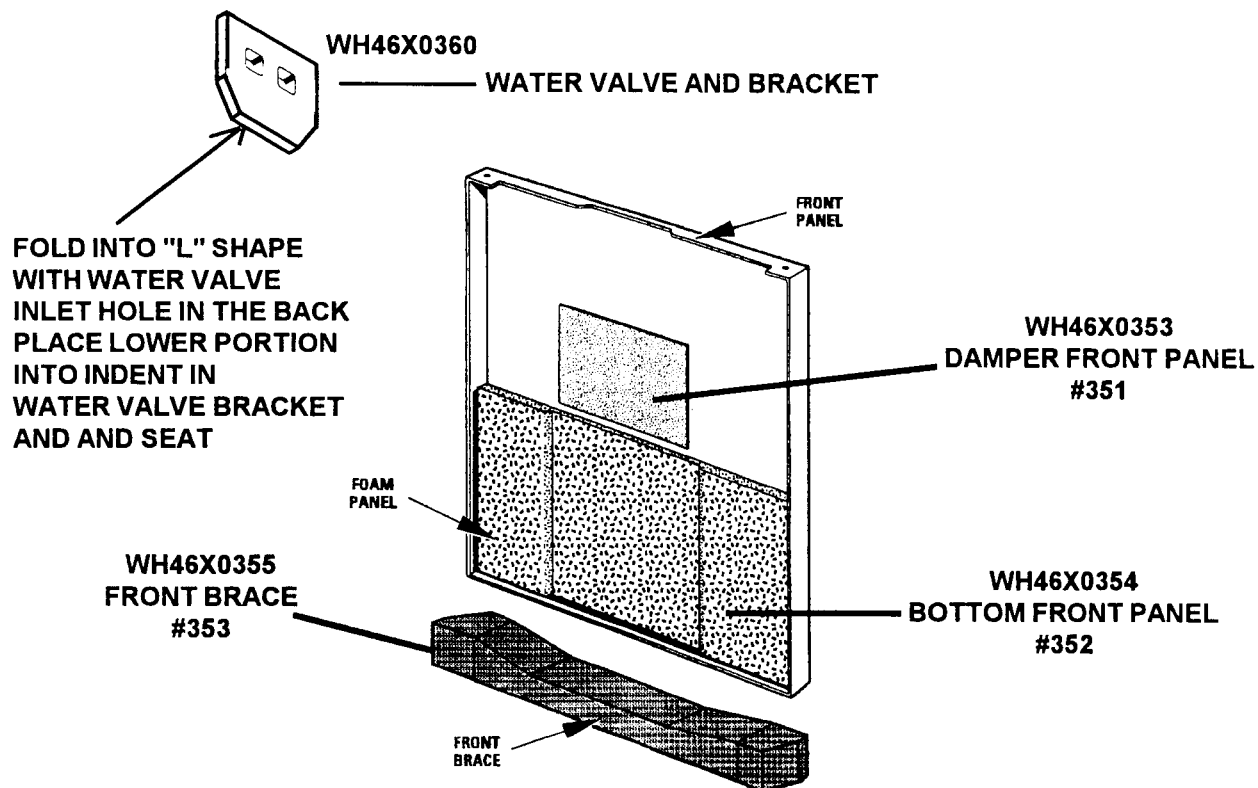
FRONT PANEL PLACEMENT (Kit WH46X366)

CUSTOMER COMPLAINTS OF NOISE DURING ACTIVATION, AND SPIN IN GE, HOTPOINT AND RCA "T" LINE WASHERS-EXCLUDING PROFILE

Noise problems described above can be reduced by installation of the foam kit shown below. All of the pieces are self-adhesive, and should be installed per the illustrations on this bulletin.

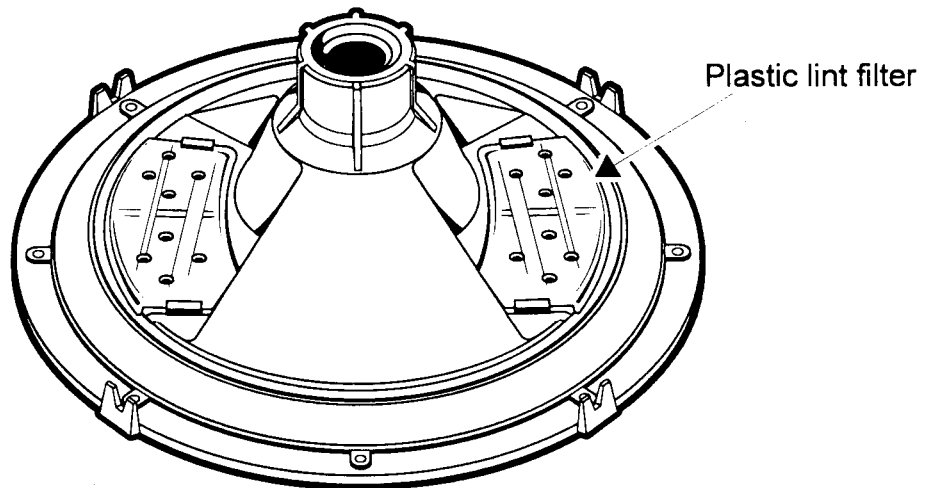
Old style hub (WH45X10013)

Effective October 1, 1998, all Louisville built GE washers are being produced with a one-piece lint filtering hub (WH45X10027). This change eliminates the need for plastic lint filters on all Louisville built washers produced after October 1. The plastic lint filter (WH1X2728) will remain in inventory as a replacement part for units manufactured before October 1, 1998.

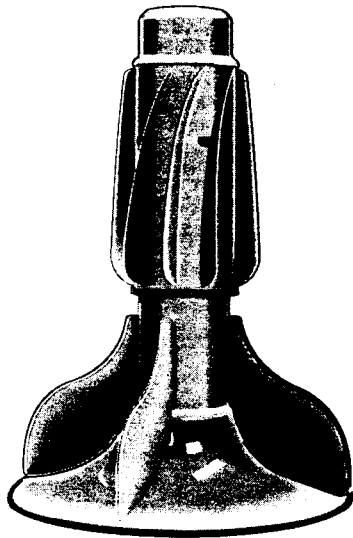
WH43X141

Typically, when an agitator floats off on front-service washers, the agitator is reseated or a new agitator installed. On service calls for a floating agitator problem, replace both the agitator and the coupling. The threads on both the agitator and the coupling can become damaged during reseating. Replacing both parts will prevent future reoccurrences.

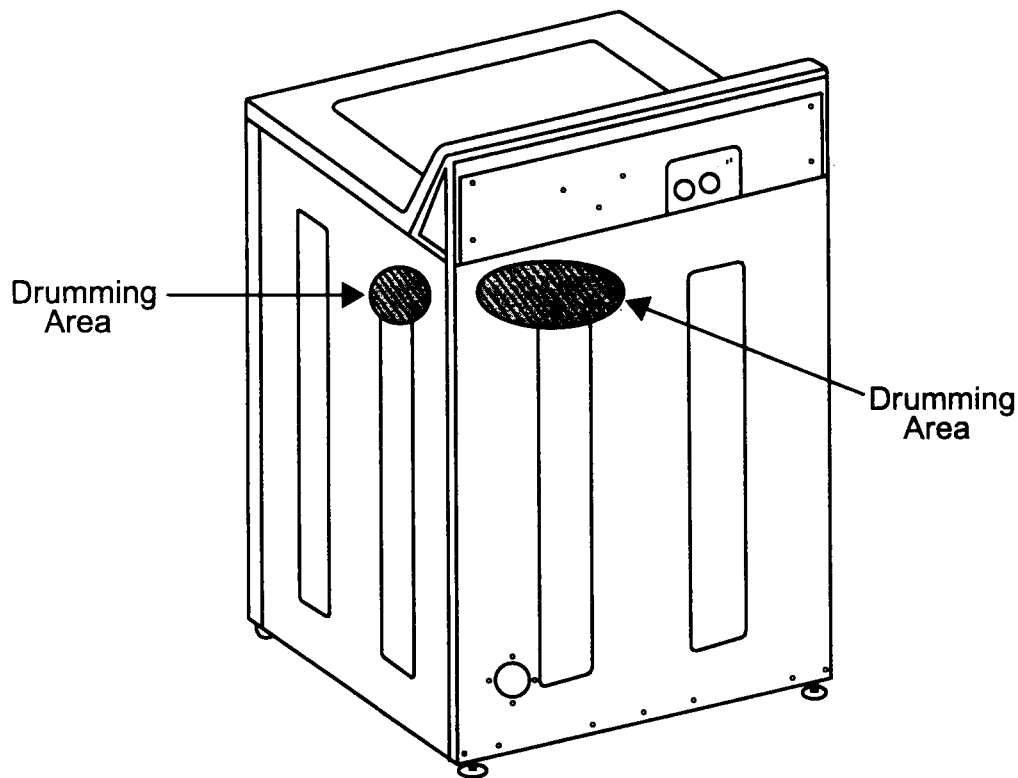
Figure 1

Cabinet drumming is the flexing of the side of the cabinet during agitate. It becomes worse as the amount of clothes in the washer is increased. A small area on the right side of the apron near the top rear OR on the back side near the top right will pop in and out. See the identified areas in Figure 1.

This is caused by variation in our manufacturing processes. We are working to address the issue in our factory. Until then you will see occasional problems with cabinet drumming. This problem does not reduce the performance or life expectancy of the washer. This field fix is intended to decrease the noise and movement caused by cabinet drumming in order to provide a more satisfactory washer to the consumer.

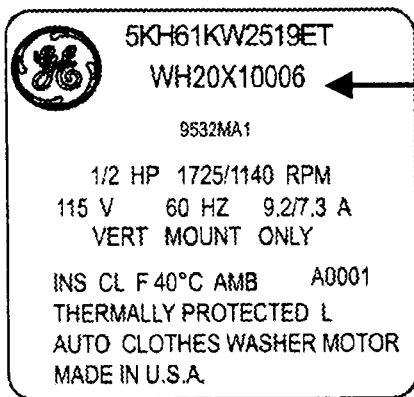
Figure 1

Motors with this model number can be used on washers with and without capacitors.

When replacing a capacitor start washer motor, either the WH20X867 or WH20X10006 series motors is acceptable. For washers without a capacitor, only use the WH20X10006 motor. The WH20X867 motor when installed without the capacitor does not have sufficient torque in low voltage situations.

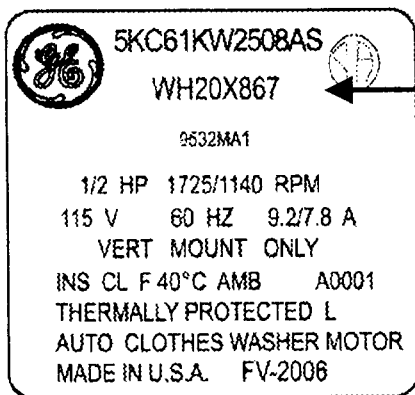
Figure 2

Motors with this model number can only be used on washers with capacitors.

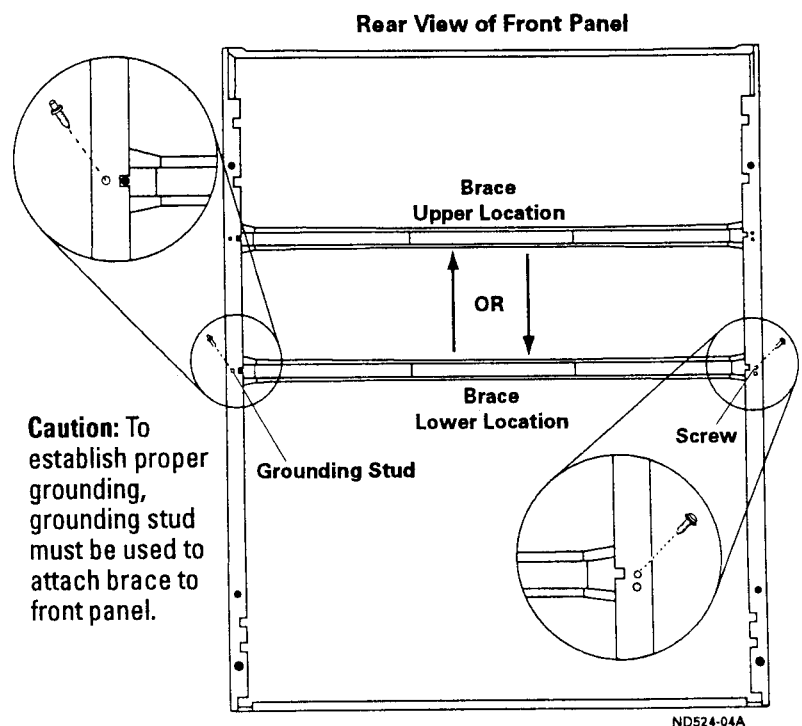
As a result of manufacturing changes and increasing concern with the possibility of improper installation, GE has developed an assembly kit (WH49X10021) to be used when replacing the front panel. The use of this assembly kit is necessary to ensure the proper installation of all replacement front panels. Improper installation issues such as, failing to install the brace or attaching the brace to the panel without the use of the grounding stud, may result in poor product performance and/or electrical shock. The kit, when used properly, will eliminate these concerns.

1. Remove existing front panel.
2. Determine correct brace location by examining existing front panel or machine's apron for previous brace location (upper or lower location). After correct brace location has been determined, discard old front panel.
Note: If wrong location is used, front panel will not assemble to machine apron.
3. Locate identifying mark (X) on the end of brace, just above screw hole. This end of the brace must be attached to front panel using the screw. The opposite end of the brace must be attached to the front panel using grounding stud. (Refer to front panel diagram, and attach exactly as shown).
4. Attach replacement front panel to machine.

Caution: To establish proper grounding, grounding stud must be used to attach brace to front panel.
