**GENERAL
ELECTRIC
COMPANY
MAJOR
APPLIANCES**

**REFRIGERATOR
and
FREEZER**

Service Bulletin — REF 7-90

**DRAIN FREEZING
TMNF 14/16 "M" MODELS**

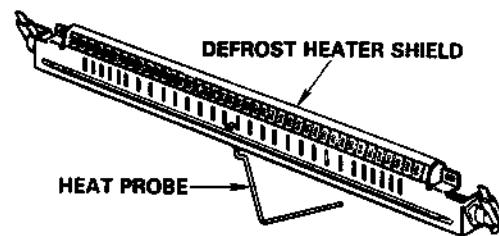
Water dripping from the air diffuser at the top of the fresh food liner, in some early produced TMNF 14 and 16 "M" (1990) models, is likely caused by defrost water overflowing the drain sump due to ice forming in the drain opening.

This condition was corrected at the factory in February, 1990 by adding a heavy aluminum wire probe to the defrost heater shield. The probe, riveted to the front of the shield and extending down into the drain opening, conducts heat from the defrost heater to prevent the formation of ice in the drain opening.
