SERVICE BULLETIN

LG Electronics Inc.

Buyer Model: LDS5811,LDF7811,LDF7810,LDF6810,LDF8812

Subject: BLDC Motor Magnet Crack

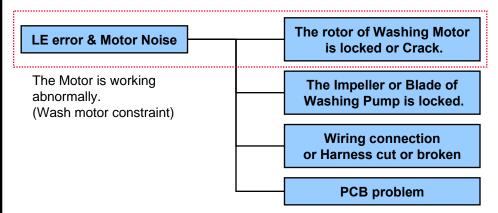
When replacing the BLDC motor (P/n 4681ED1004A) in the dishwasher, verify the motor manufacturing date as shown below. Improved BLDC motor began 15 March 2007. (Verify date on motor – the part number has not been changed)

4.SVC Method

Improved parts have been applied to all models that were produced since 15 March 2007. Use the following diagnostic chart to determine if the motor needs to be replaced.

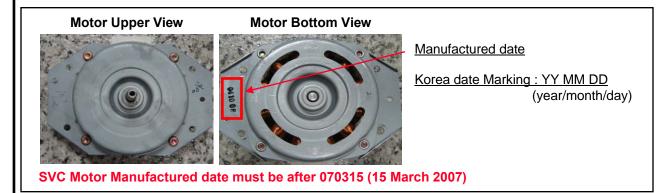
Manufactured date is marked on the bottom of upper bracket.

The date code is the only visible difference between parts. The part number is unchanged.

If manufacturing date is before 15 March 2007 DO NOT USE THE MOTOR.

All old stock (dated prior to 15 Mar 2007) must be scrapped. All old motors will be replaced with new stock.
