Automatic Washers

(Maytag, GE, Amana, Speed Queen, Frigidaire, &
Westinghouse)

Manual 3

Harry D. Raker

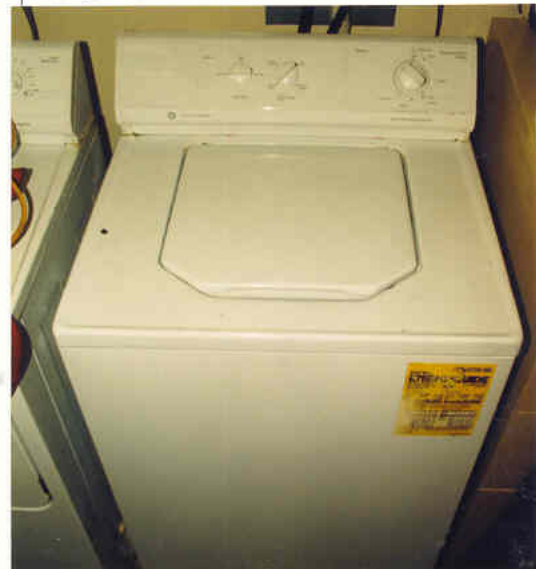
Typical GE Washer (Fig. 031-01)

It is a reliable washer that is simple to diagnose and repair. The top folds back for basket access, exactly like the Whirlpool belt-driven model. After removal of a Masonite cover, the entire back is open for service. Instead of placing a paint can under a front leg like we do on Whirlpool, it is frequently helpful to place one under a back leg. Many repairs are done from the rear and the top.

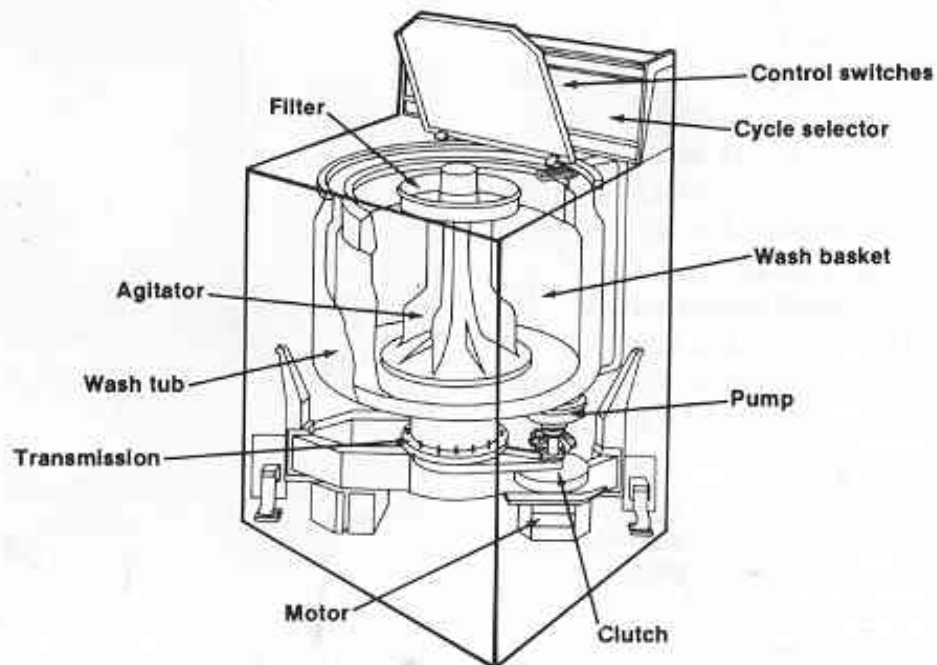
**GE Washer Exploded View
(Fig. 031-02)**

The GE washer is different in mechanical layout from either the Whirlpool belt-driven or the Whirlpool direct-drive. However, the basic theory is similar to that of the Whirlpool direct-drive. The motor reverses between wash and spin. The pump design is also basically the same. The timer does not pause during spin like Whirlpool. Instead the clutch slips, providing a slow spin during the early part of the spin cycle. The clutch gradually brings the clothes basket up to full speed, as all the water is pumped out.

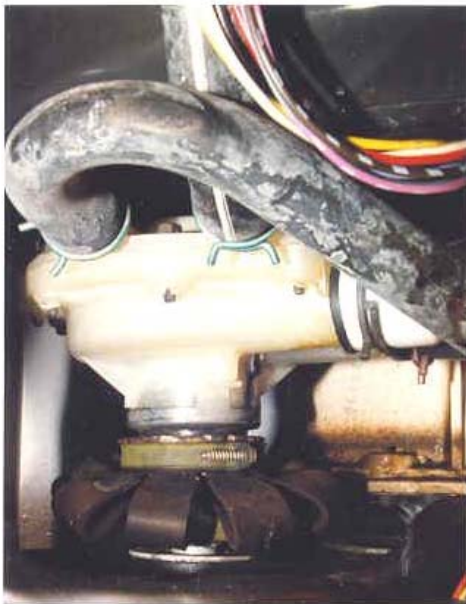
GE Pump and Pump Web (Fig 031-03)

GE uses a plastic centrifugal pump much like a direct-drive Whirlpool, Maytag and many other brands. It drains the tub in one rotation and sucks water from the drain hose in the other. The pump pulley is connected to the clutch assembly by a flexible webbed canvas coupling. GE has a second smaller pump built on top of the same body as the main pump. The smaller pump recirculates water into a lint filter sitting on top of the agitator.

They leak water in two places. First they leak through the pump weep hole. (A small hole just above the pump drive pulley.) Second, they leak around the pump drive shaft.

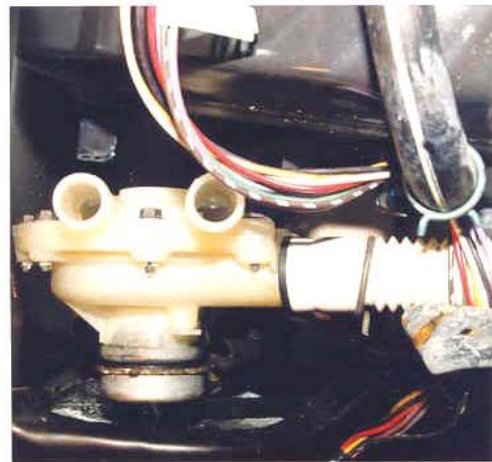
Replacing a GE Pump (Fig. 031-04)

A GE pump can be replaced while the machine is completely full of water. The procedure is fairly simple.

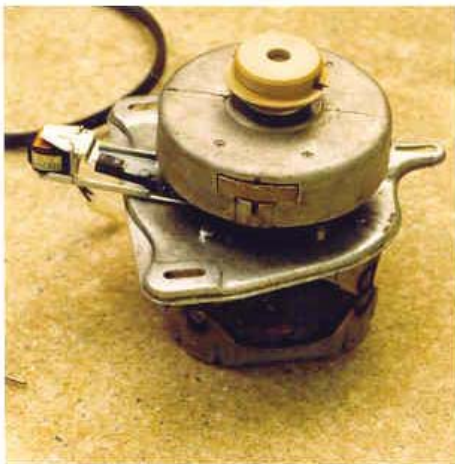
GE Motor and Clutch Assembly (Fig. 031-05)

Strange noises are the usual indicator of a bad clutch. The main wearing point of the clutch are the primary shoes. These shoes are the heart of the single and two-speed clutch. Worn out primary shoes make a lot of noise as they grind against the cast iron clutch drum. The washer will make noise in wash and even more noise in spin. If you hear a high speed rattling or grinding noise, suspect the clutch. Take off the cardboard back of the washer and push it to the side. It's not necessary to remove it completely.

1. Removal of the clutch and motor unit can be accomplished by tilting the machine forward, just like the procedure for pump replacement.
2. Remove the web from the top of the clutch.
3. Get your arms under the motor unit and remove the three 7/16" nuts that hold the motor mount against the frame of the machine. Slip it forward, toward the center of the machine, so that the belt will easily come off. Carefully, drop the unit down into your hands.

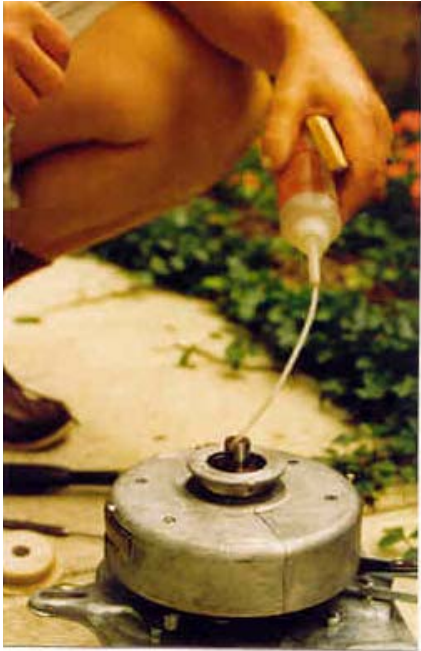
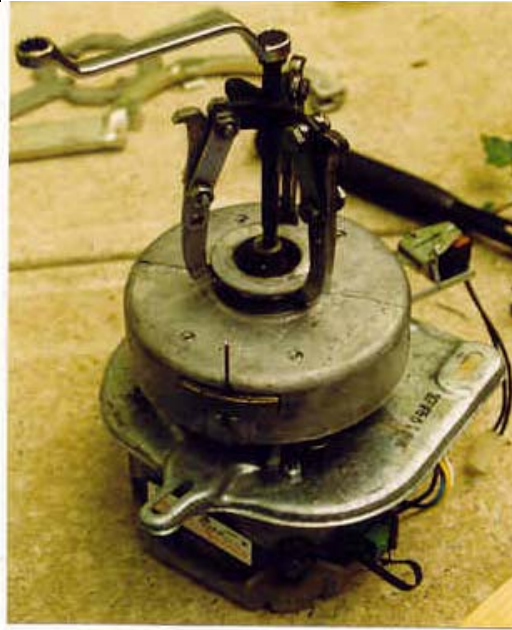
(Fig. 031-07)

Rebuilding a Two-Speed Clutch

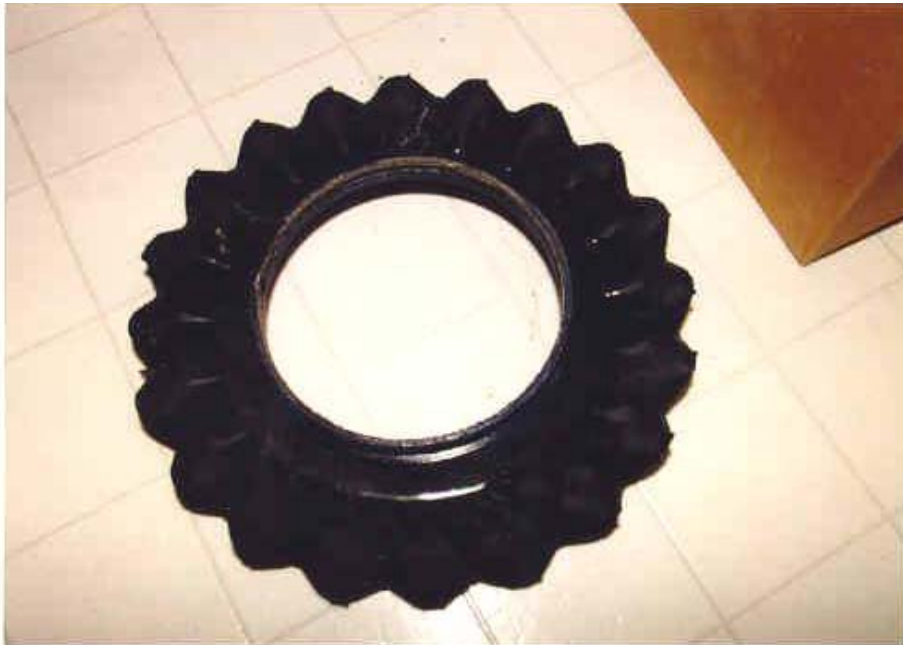
As you would expect, the boot will stiffen, crack, and leak as it gets older. As the rubber gets old and hard, it will become stiff and pull loose from its clamps. A leaking boot is a common problem on GE washers. Water will dribble down the side of the transmission and onto the floor. If the boot is only cracked, the leak will be minor; if the clamps have come loose, the leak will become a flood.

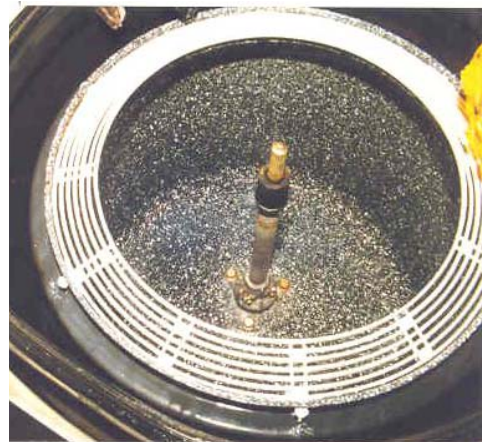
GE Clothes Basket Showing 12 Point Bolts (Fig. 031-09)

6. Remove the two large stainless steel clamps that hold it and remove the boot. The clamps seldom rust up but be careful not to twist them. Use a nut driver on one side and pliers to hold the other.

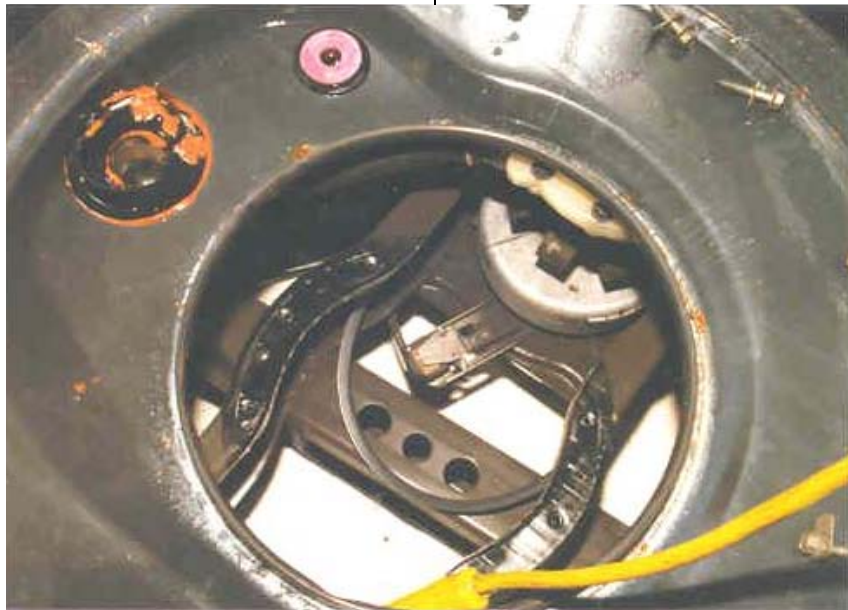
GE With Boot and Transmission Removed (Fig. 031-10)

Make sure, when you're re-installing the tub boot, that the surfaces you're clamping are clean and dry. It's a little bit upsetting to put the thing together and have it leak. You can leak test the washer with the basket out and the top up.

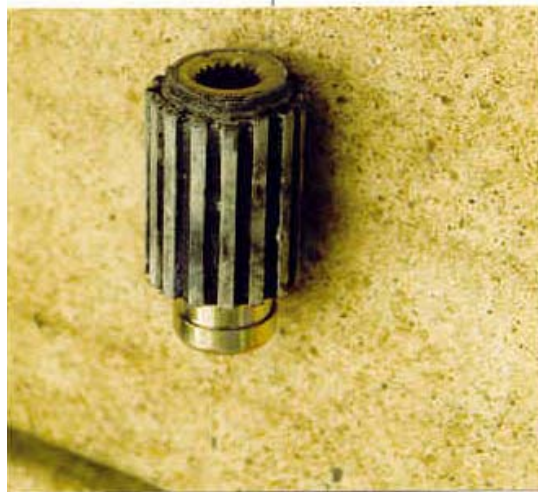
Agitator Spline (Fig. 031-11)

If removing the agitator intact seems hopeless, crush the top section of the agitator with a large pair of channel locks. If you are able to crack the top, it will be possible to remove the agitator without removing the rubber spline.

Occasionally, the rubber spline will strip inside the agitator. The spline can be driven out and replaced without replacing the entire agitator. If the washer sounds normal, but it will not agitate, remove the agitator cap and observe the drive shaft during agitate. If the shaft is moving normally and the agitator is still, the spline is bad.

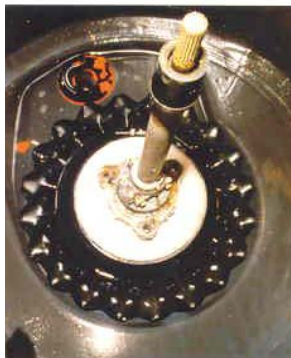
GE Boot and Transmission Hub (Fig. 031-12)

1. The most common problem is an oil leak. Oil leaks from the places mentioned before.
- 2.. The drive pulley shaft seal leaks and a puddle will form on the floor or the oil will splatter all over the inside of the cabinet.
3. The main tub seal will fail and oil will leak into the washtub and soil the clothes.
4. The gears will wear inside the transmission and begin making thumping and clunking noises during agitate.
5. The gears may fail and agitation will cease during wash or braking will cease.
6. The top of the agitator drive shaft (the splined section) will rust out and not drive the agitator spline.

The GE transmission is the easiest transmission of all to replace. It is a five minute extension of a boot replacement. Once the boot is removed the transmission bolts are accessible from the top.

1. Using a long 3/8" socket wrench, remove the transmission bolts and lift the transmission right out through the top of the machine. It is not necessary to take the back off the machine.
2. Continue working from top, replace the new transmission and thread the belt onto the drive pulley,
3. Replace the six transmission bolts and then reassemble the machine as described on the boot replacement.

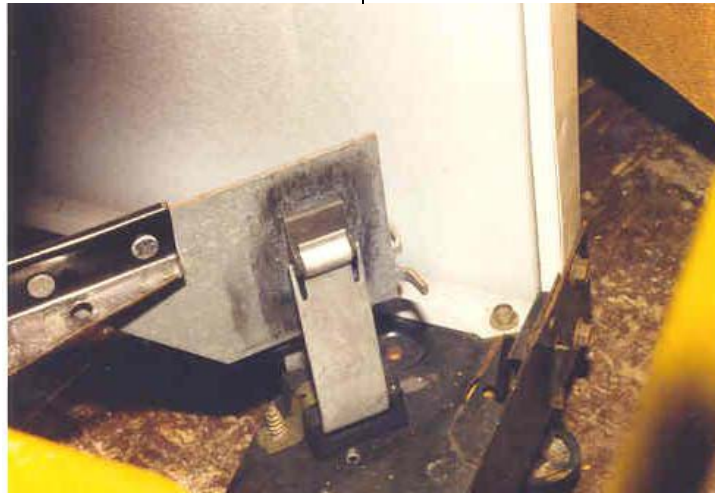
GE Snubber Arm Assembly (Fig. 031-16)

Occasionally the suspension system wears out on a GE washer. It will bang and make a racket in agitate or spin as the suspension arms hit the cabinet. The noise is easily distinguished from a clutch failure. It is timed with the swinging of the wash basket, instead of the motor speed. The problems usually are in the snubber arms mounted in each corner. There are three sets of sliding plates that are bolted to the frame of the washing machine. Replacement is simple enough once the correct parts are ordered.

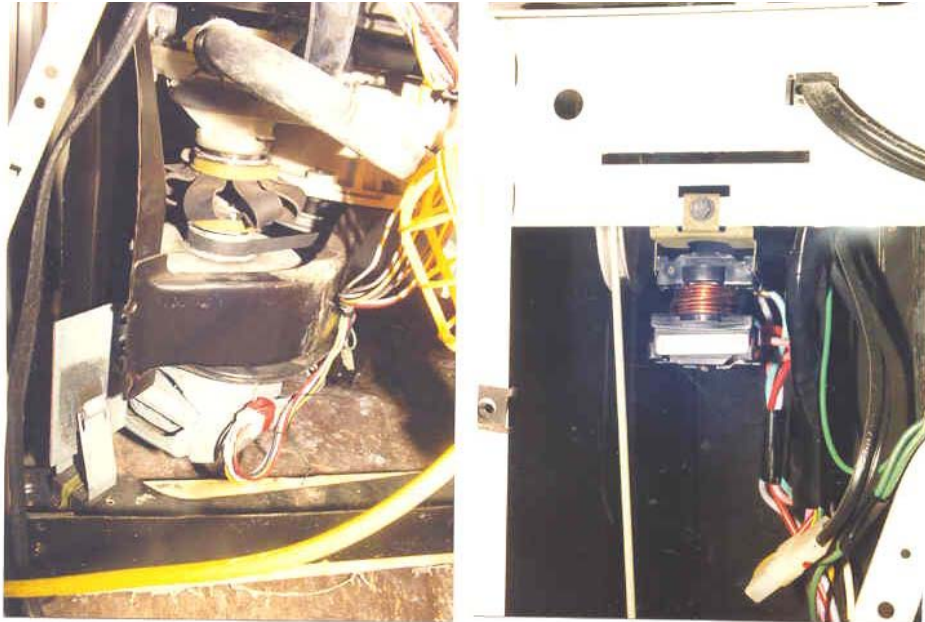
GE Motor and Remote Starting Switch (Fig. 031-18)

The drive motor on a GE is a reversing single-speed motor. It has a remote start switch that is bolted up near the timer on the back panel. Motor replacement requires the same procedure that was described for the motor and clutch assembly repair.

The remotely mounted starting switch can also cause problems. It can be replaced separately. A bad starting switch is indicated if the motor hums instead of starting and will start up with a little push. Having a test switch in stock is the easiest diagnostic method.

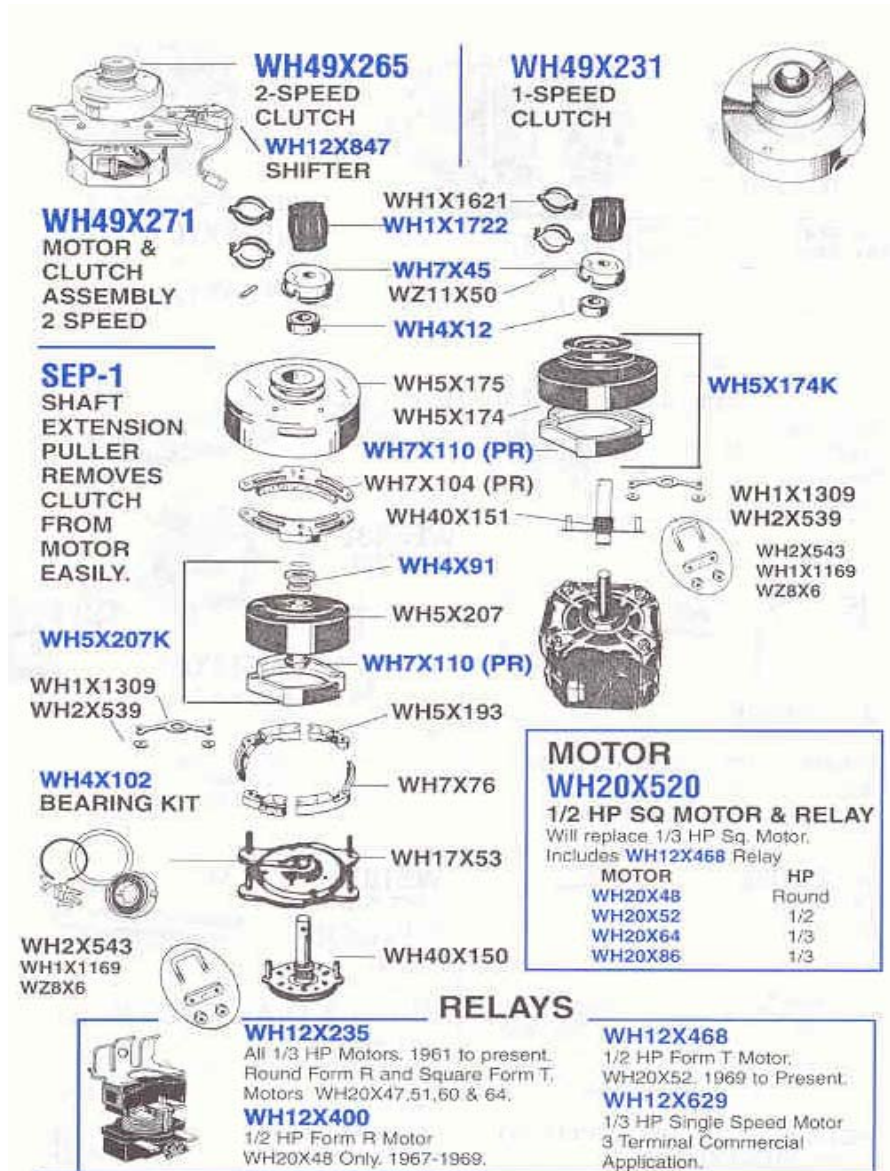
(Fig. 031-19)

**GE Drive Motor and Clutch
(Exploded View)**

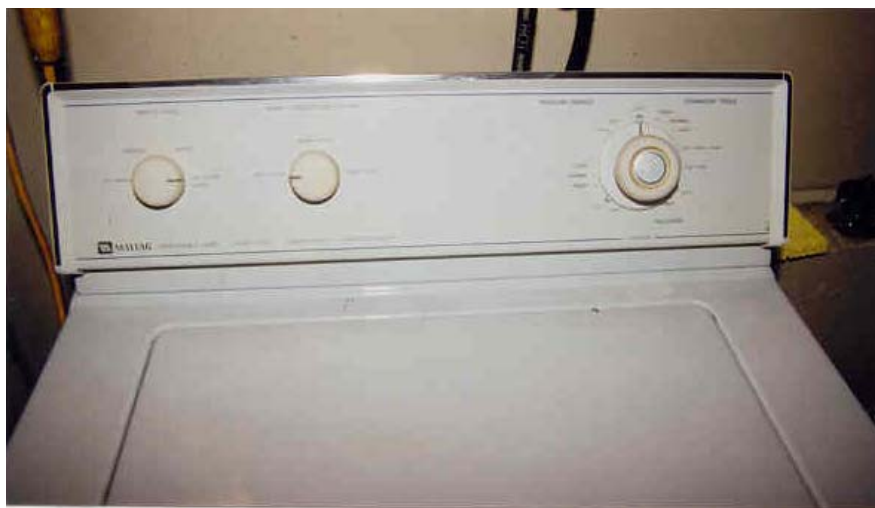
Typical Maytag Washer (Fig. 032-20)

In theory, Maytag is very similar to GE. The motor reverses to switch from wash to spin; it's a belt-driven machine; and, it has a large central transmission. However it does not use a clutch like a GE. **Clutch action is accomplished by spring loading a slipping drive belt.** Maytag is designed for ease of service. It is a front-service washer.

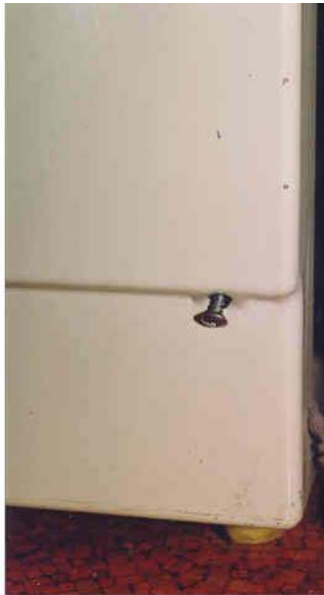
Hidden Cabinet Screws (Fig. 032-21)

Two screws near the bottom of the front panel allow access to the whole front of the machine. Two 3/8" bolts allow the top of the machine to flip back. Virtually anything that's wrong can be serviced without pulling it out from the wall or even disconnecting the water and drain lines.

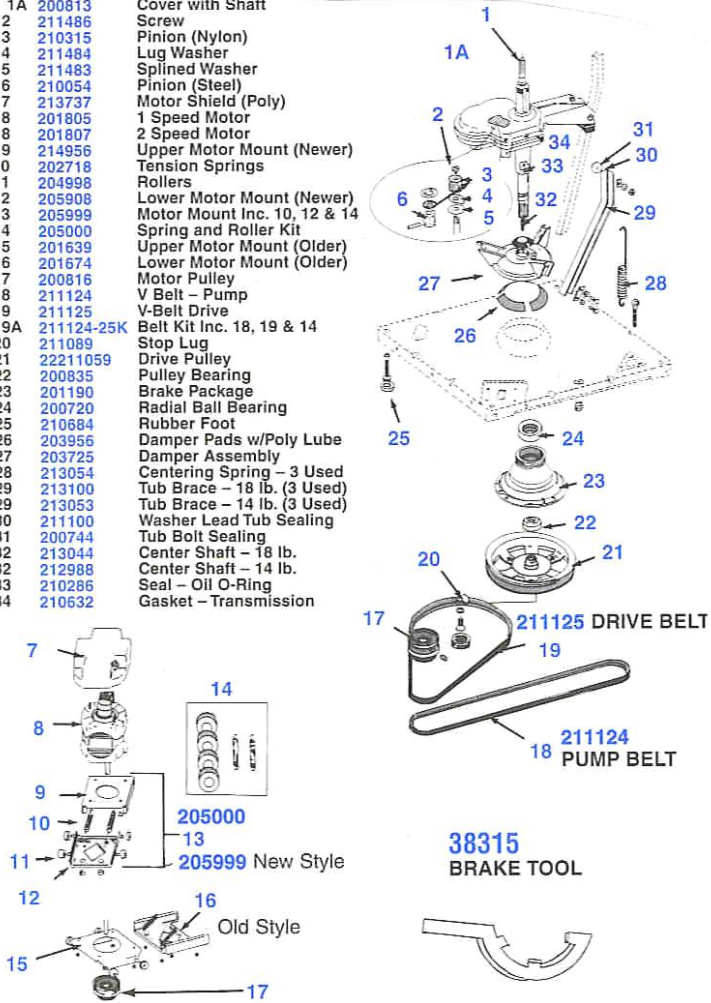
(Fig. 032_23)

**Removing the Front Panel and
Maytag Exploded Views
(Fig. 3-23)**

Key	Part Number	Description
1	200730	Agitator Shaft
1A	200813	Cover with Shaft
2	211486	Screw
3	210315	Pinion (Nylon)
4	211484	Lug Washer
5	211483	Splined Washer
6	210054	Pinion (Steel)
7	213737	Motor Shield (Poly)
8	201805	1 Speed Motor
8	201807	2 Speed Motor
9	214956	Upper Motor Mount (Newer)
10	202718	Tension Springs
11	204998	Rollers
12	205908	Lower Motor Mount (Newer)
13	205999	Motor Mount inc. 10, 12 & 14
14	205000	Spring and Roller Kit
15	201639	Upper Motor Mount (Older)
16	201674	Lower Motor Mount (Older)
17	200816	Motor Pulley
18	211124	V Belt - Pump
19	211125	V-Belt Drive
19A	211124-25K	Belt Kit inc. 18, 19 & 14
20	211089	Stop Lug
21	22211059	Drive Pulley
22	200835	Pulley Bearing
23	201190	Brake Package
24	200720	Radial Ball Bearing
25	210684	Rubber Foot
26	203956	Damper Pads w/Poly Lube
27	203725	Damper Assembly
28	213054	Centering Spring - 3 Used
29	213100	Tub Brace - 18 lb. (3 Used)
29	213053	Tub Brace - 14 lb. (3 Used)

30	211100	Washer Lead Tub Sealing
31	200744	Tub Bolt Sealing
32	213044	Center Shaft - 18 lb.
32	212988	Center Shaft - 14 lb.
33	210286	Seal - Oil O-Ring
34	210632	Gasket - Transmission

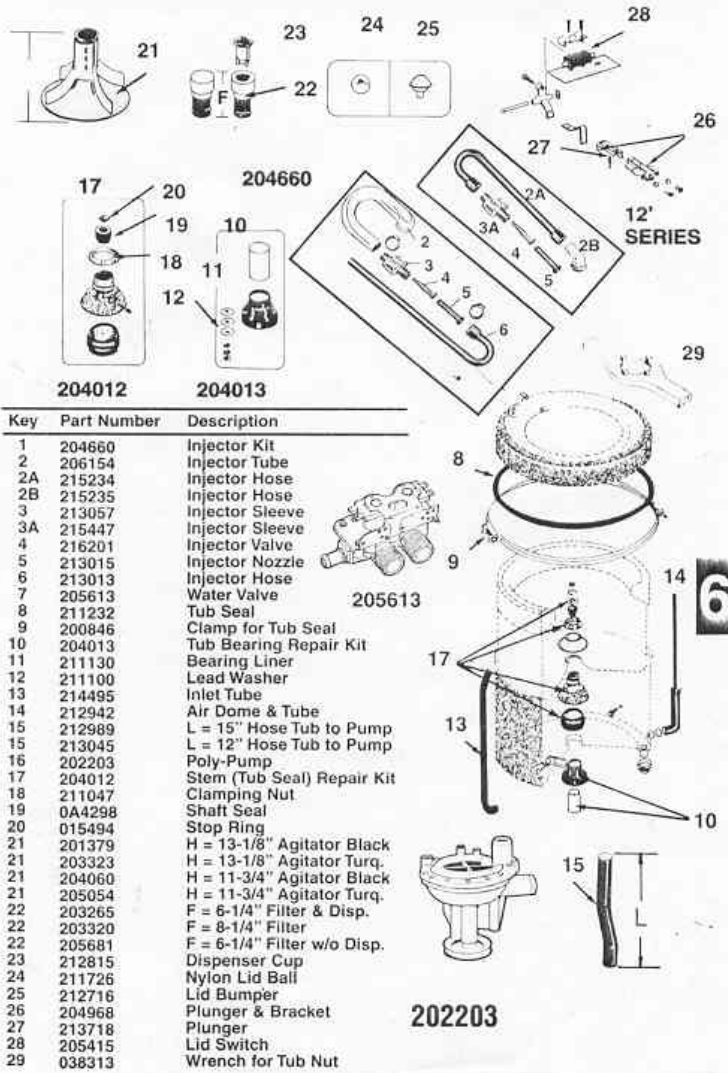
Maytag Exploded Views (cont.)
(Fig. 032_24)

FOR MAYTAG WASHER TUB & SEALS

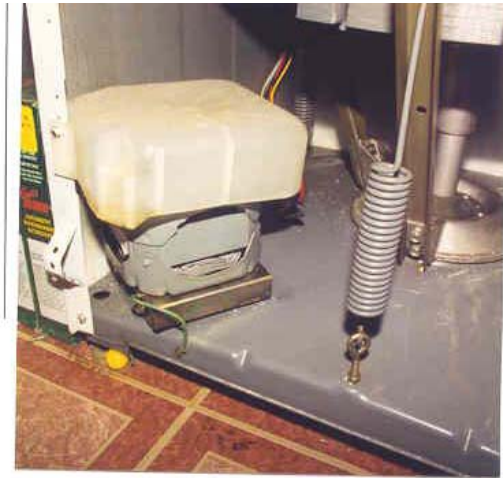
**Motor, Carriage and Protective Cover
(Fig. 032_26)**

As mentioned, the motor sits on the carriage which enables the motor to move back and forth about 3/4". The springs add tension to the drive belt during the wash and spin cycle. The rollers in the carriage are plastic. When they get old, they may crack. Sometimes bleach will spill down on the front left corner of the machine from the bleach dispenser and rust up the carriage. It will rust in one position and fail to tension the belt properly.

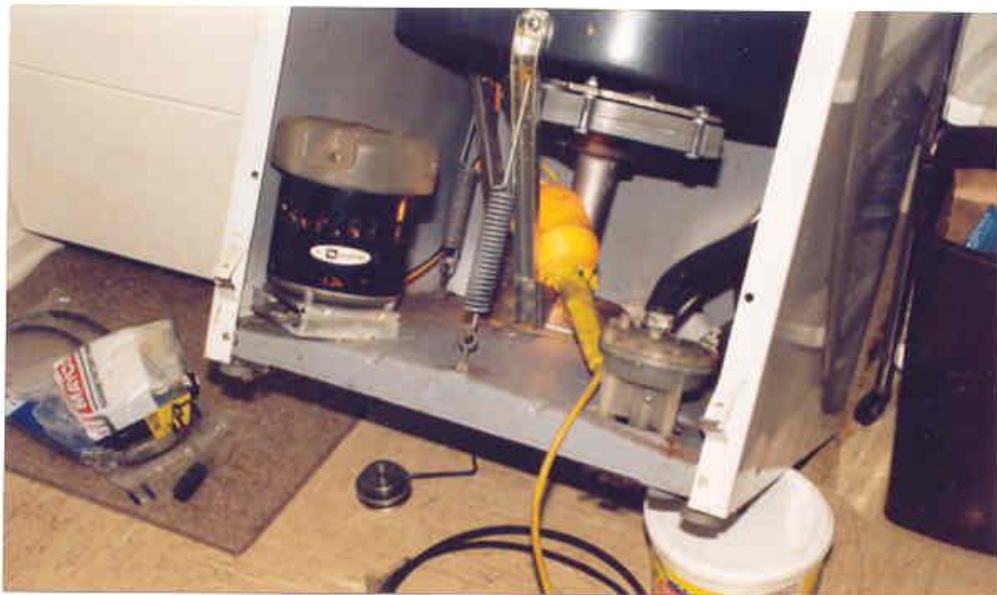
**Installing a Belt Set and Motor Pulley
(Fig. 032_25)**

To replace a Maytag belt set, remove the front from the machine and tilt it back against the wall and put the old paint can underneath a front leg. The belts can be rolled off with finger pressure very easily and the new set installed.

However, there is one critical thing, carefully described on the belt bag. The pump belt runs loose, **so loose that it looks like it might fall off.**

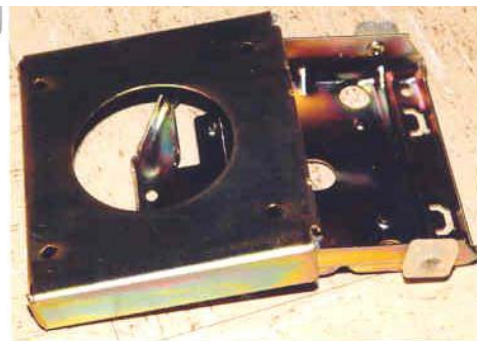
A Carriage Kit (Fig. 032_29)

New carriages mount differently from the old, with sheet metal screws rather than bolts and nuts holding it to the washer base plate.

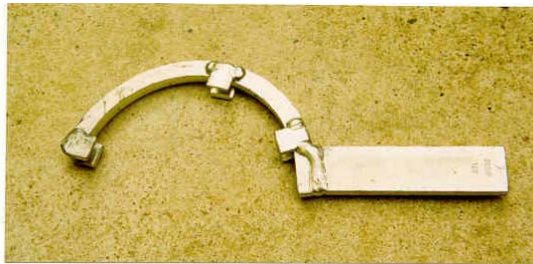
Brake Wrench (Fig. 032_32)

1. Tilt the washer, back toward the wall, and remove the belt set.
2. Remove the transmission pulley. Note the position of the drive lug on the transmission input shaft
3. Remove the hex-bolt and clip locking the brake threads
4. Using a Maytag special tool, # 38315, unscrew the brake assembly. A hammer and chisel may work, but it could ruin the old or new brake. The brake is usually very tight. Be careful.

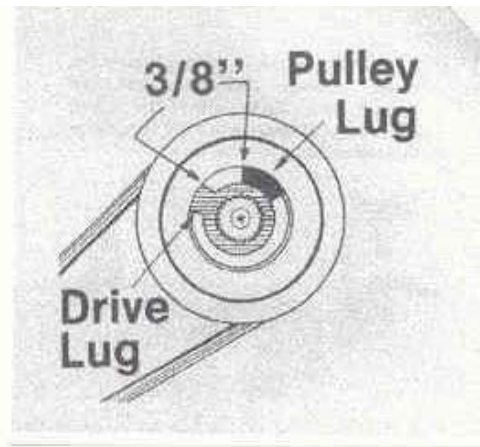
On Reassembly, Reinstall the Pulley as Sketched (Fig. 032_33)

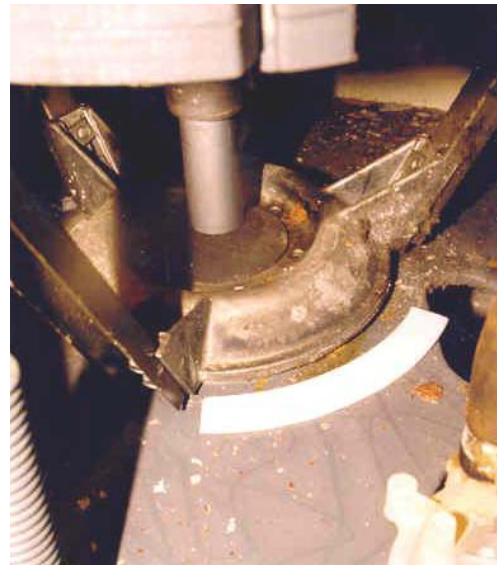
A Sample Snubber Pad Next to the Housing
(Fig. 032_34)

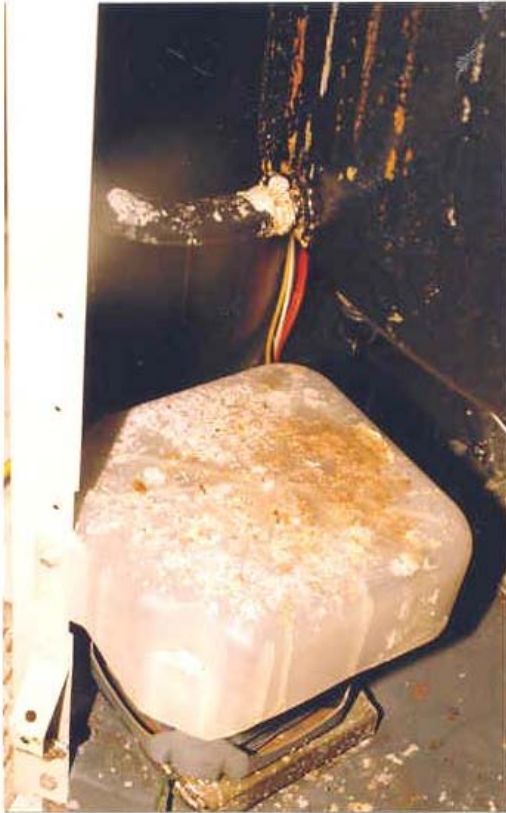
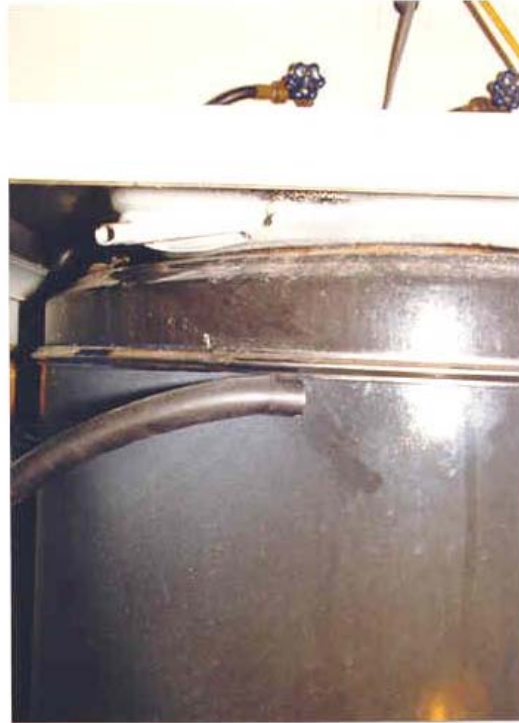
Washer Damaged by Leaking Bleach and a Loose Hose (Fig. 032_37)

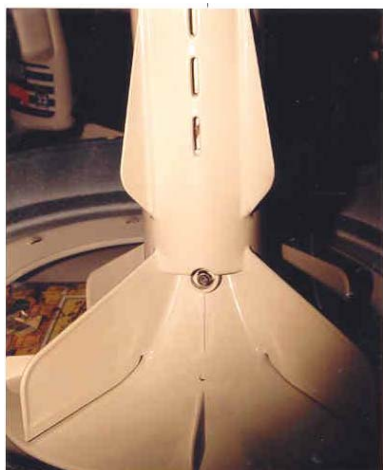
New Style Agitator (Fig. 032_38a)

2. Remove the agitator. The older style Maytag’s had an “O”- ring built into the bottom of the agitator. It hardens with age and making it very difficult to pull the agitator off the top of the agitator drive shaft. When this becomes a problem, follow the technique that was described on the GE washers. Use baling wire and make a sling. Use a crowbar against the top of the machine with a wooden block for protection. Pull up on the agitator to get it loose. Wind up the temporary sling to tighten it.

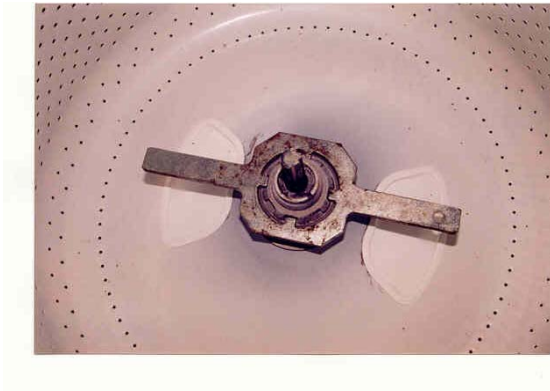
**Tub Nut Wrench
(Fig. 032_39)**

5. Upon lifting out the washtub, you will see the casting on which the washtub rests. A setscrew locks in the tub mount threads. On the older models the screw is an Allen, on newer models it is a #15 torx screw. After removal of that locking screw, unscrew the tub mount with the same wrench.

Again, it is a left-handed thread.

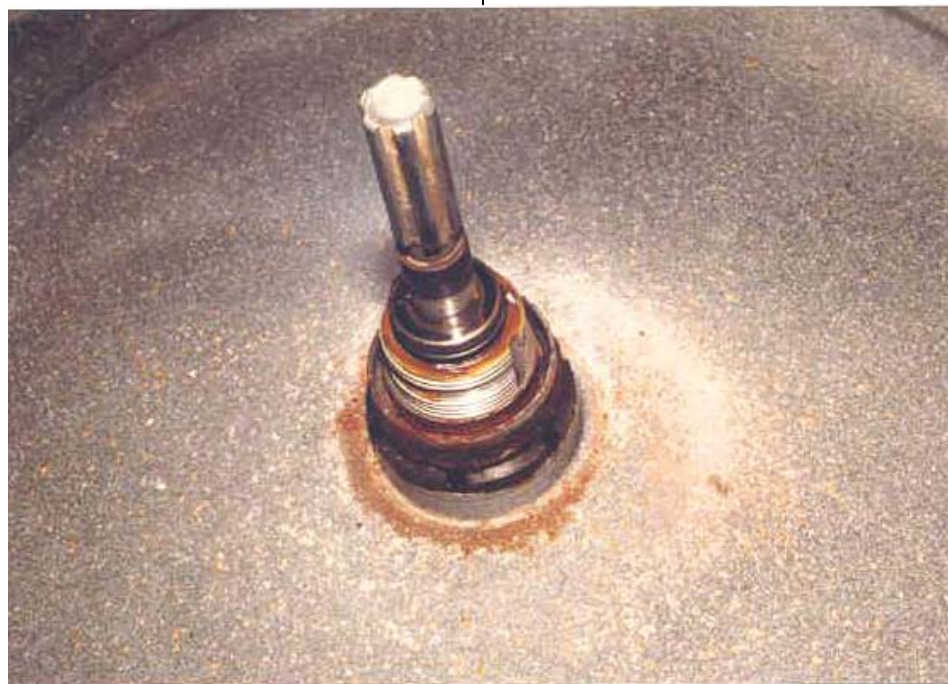
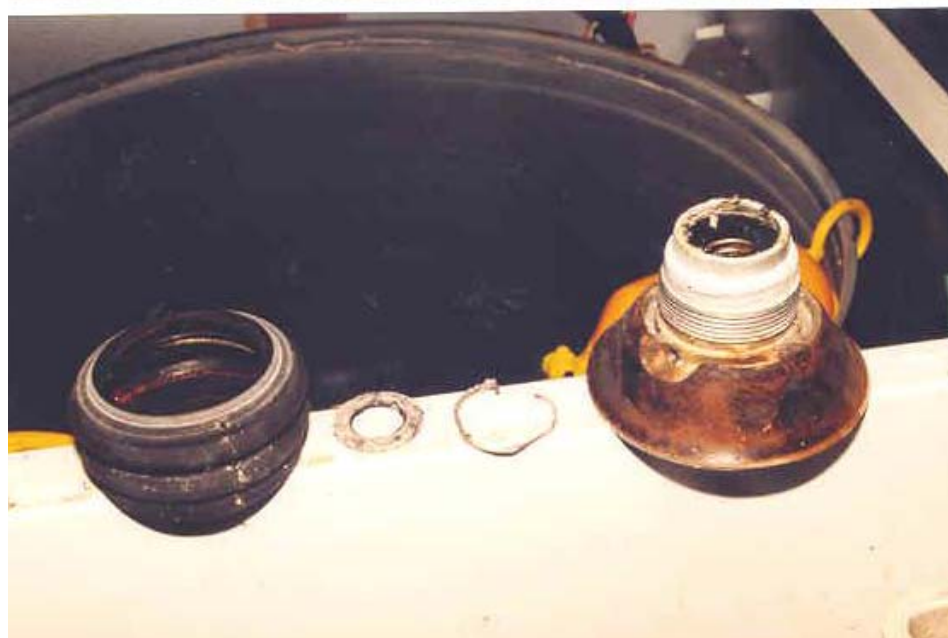
**Replacing a Boot and Stem Kit
(Fig. 032_40)**

Clean the outer tub and either wet it with your fingers a little oil. The new boot will slip easily in place. Prior to installing that boot, the long bearing that supports the top transmission was exposed. This large sleeve bearing very rarely goes bad. At this point, if you proceed and remove the outer tub, the entire transmission and upper bearing could be removed.

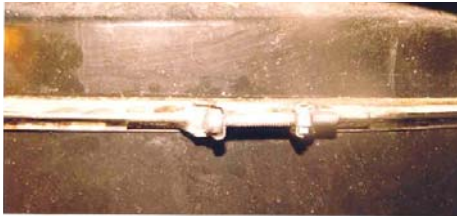
Tub Ring
(Fig. 032_40a)

The reassembly process. Replacing the stem and boot kit, is straightforward with one exception. When re-installing the outer tub top, the clearance between the top of the clothesbasket and the tub top is critical. It must be adjusted so that the basket doesn't rub. There is not a great deal of clearance.

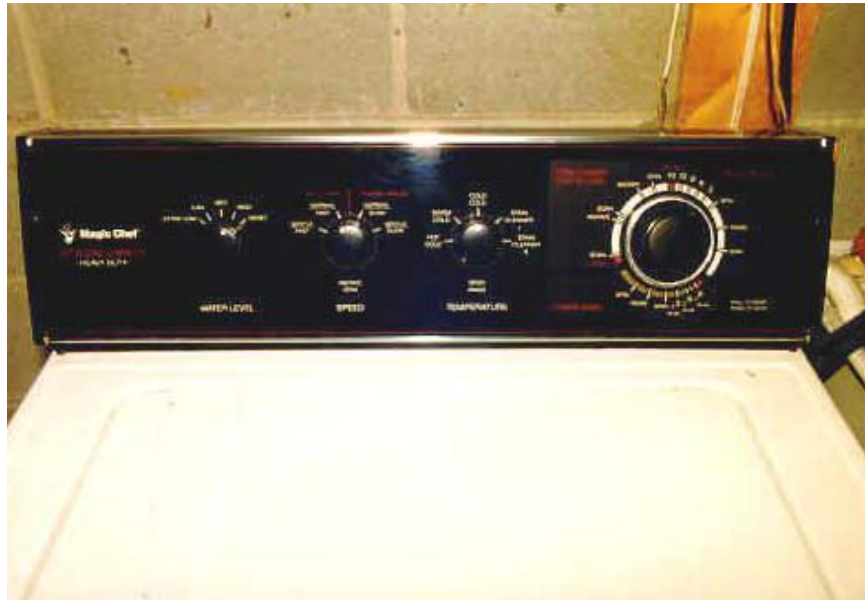
A Magic Chef by Norge
(Fig. 033_44)

The current style Norge washing machine is similar in theory to the Maytag. It is the reversing motor style washer with 2-hose drain pump. It also has a spinning. The significant differences are:

1. Norge has a single belt operating on three pulleys, instead of two belts like Maytag.
2. The clutching action is provided by a spring mechanism inside the transmission rather than a slipping belt as is the Maytag, or an external clutch like GE.

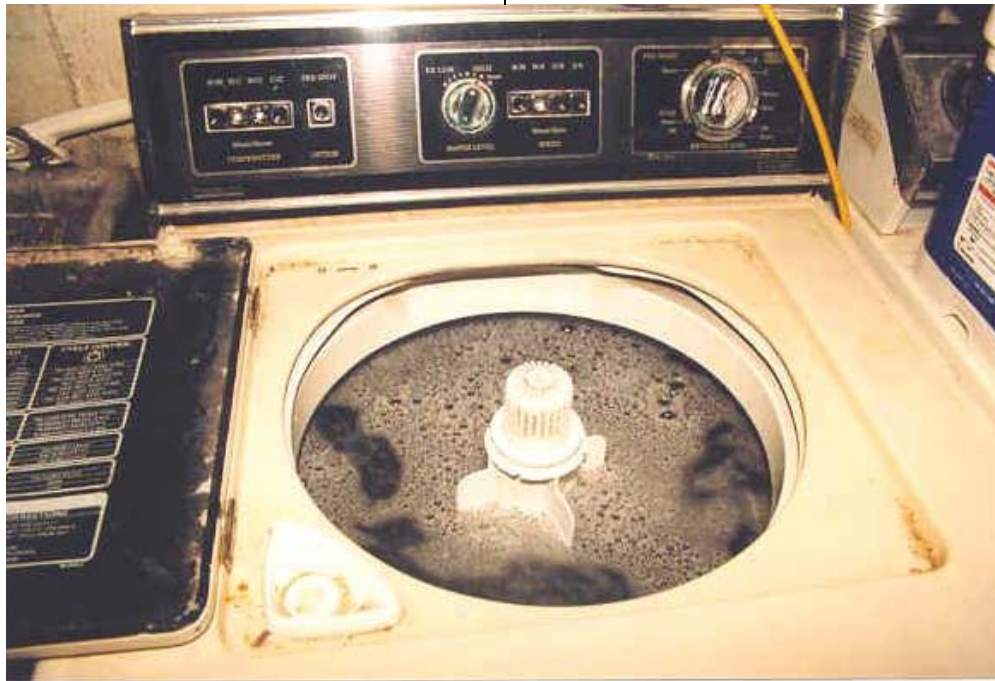
**An Old Norge Washer
(Fig. 033_46)**

Older Norges were of a similar design, but they had some significant differences. The original ones had a solenoid brake locking system mounted at the base of the transmission. This brake arm kept the transmission from rotating until 2/3 of the water was out of the big tub. The solenoid energized and allowed the washing machine to spin. The heavy brake system also provided an emergency stop when the lid was lifted.

These older design are easily distinguished by the loud "clunk" noise heard when the lid is lifted during spin. The system had its own set of failures

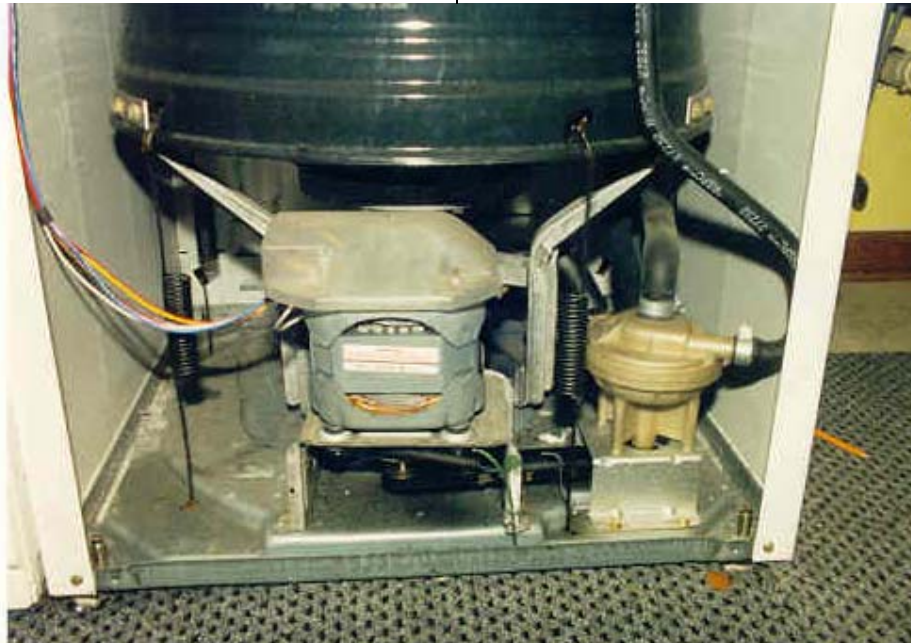
Current Speed Queen Layout (Fig. 033_49)

The overall design of a Speed Queen washer is a close copy of the Maytag design. The layout of the components and the operating methods are the same. The manufacturing quality, however, is not and the machines don't hold up for very long.

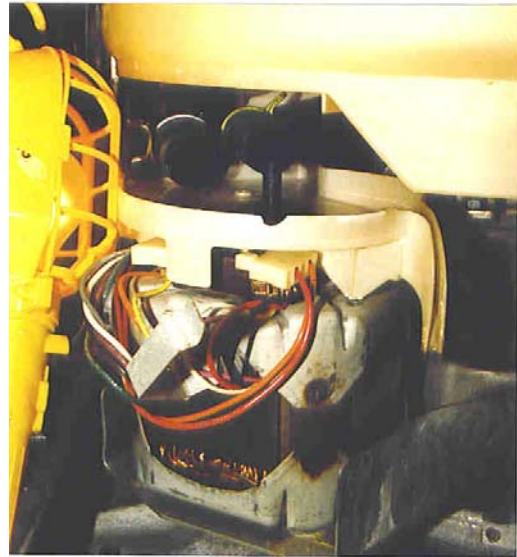
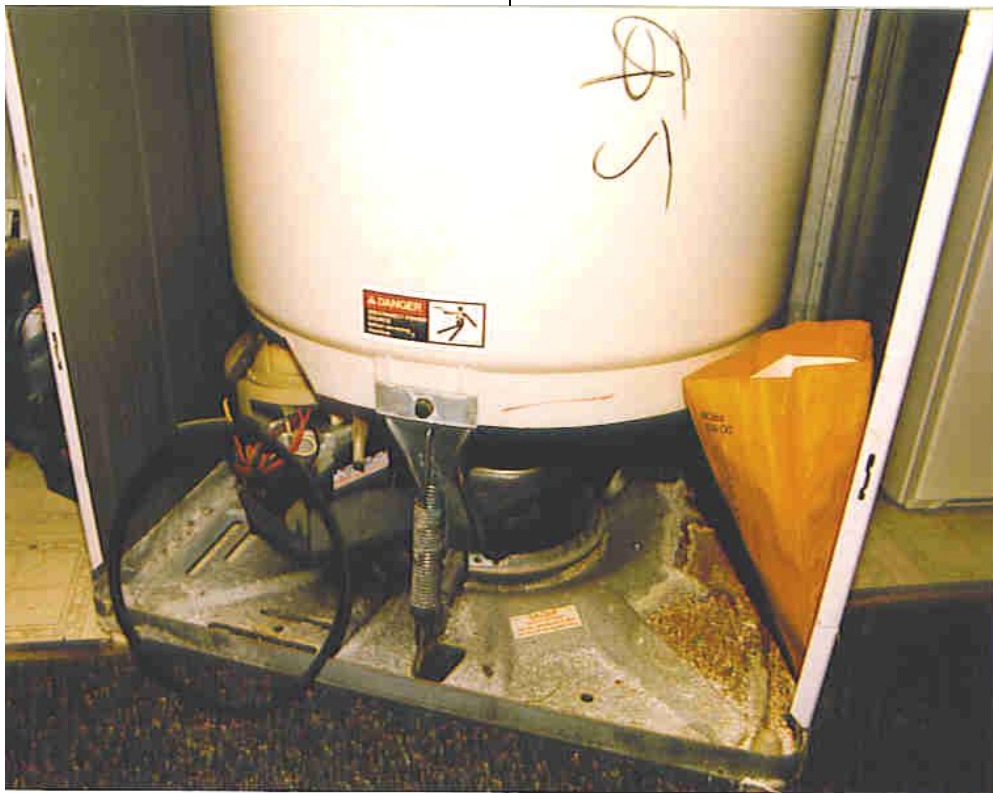
**Belt and Pump Replacement on a Current Frigidaire
(Fig. 033_53)**

More recent models have changed the design making belt replacement much easier. Also the pump can now be replaced without difficulty.

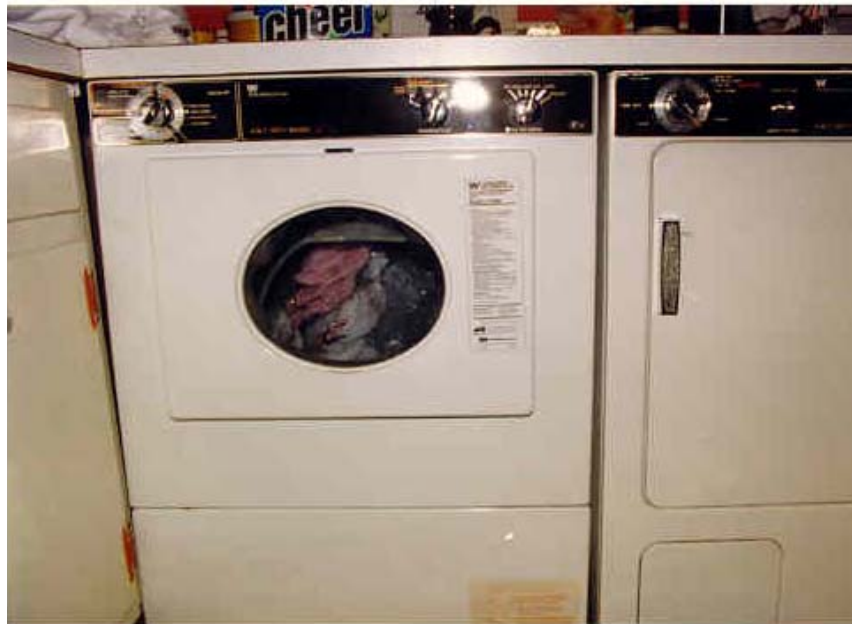
Westinghouse Front Loader (Fig. 033_54)

Prior to the 80's, Westinghouse, Frigidaire, and Gibson all had their own manufacturing plants and their own unique designs. Hopefully you will not be unlucky enough to encounter one of these in your service work. If you do draw on the knowledge gained from other designs and apply it to the unfamiliar design.
