Dishwasher Service Handbook

Service Handbook LDF6920 + V1 090603
 Service Handbook LDF6920 + V5 100525

Model : 24" Built In Dishwasher

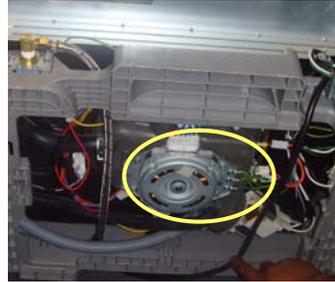
Washing motor problem

If the motor does not run,

- Check the door is tightly closed.
- Check door switch operation.
- Check wiring connections or PCB.
- Check that chopper blade is not locked by a foreign objects.
- Check wash motor.

If you hear grinding noise,

- Check Blade.
- Refer to the **SUMP Assemble & Disassemble** and **SUMP EXPLODE VIEW** to check chopper blade. (See page 3~4)
- If you find the debris, remove it.

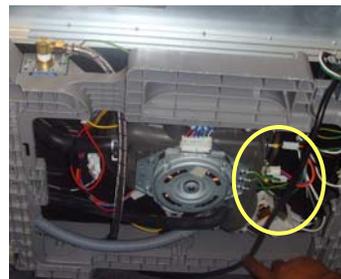
Bottom area

- For 10 seconds check the power or current by using probe (8A ~ 10A)
- remove junction cover
- contact the probes to Black, White harness wire.

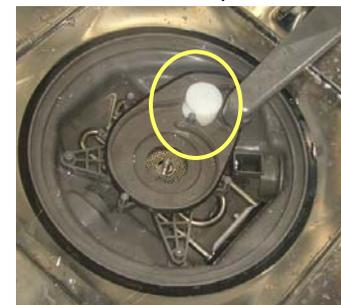
In the sump

- Check **.Check the resistance of vario motor**
- Discor **.Check the loose fitting of micro s/w "**
- Check **.Heavy soil remain around the valve** ever is pressed.

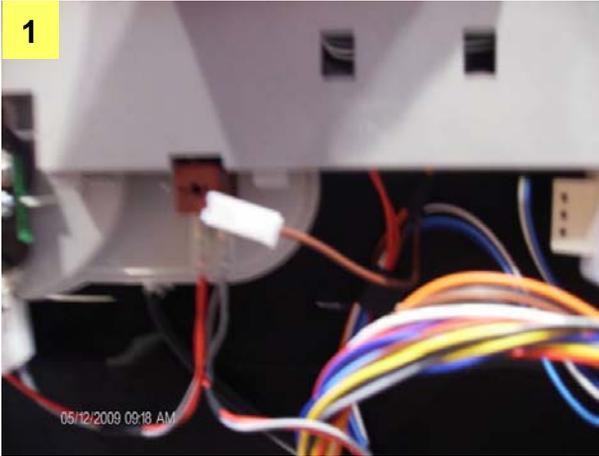
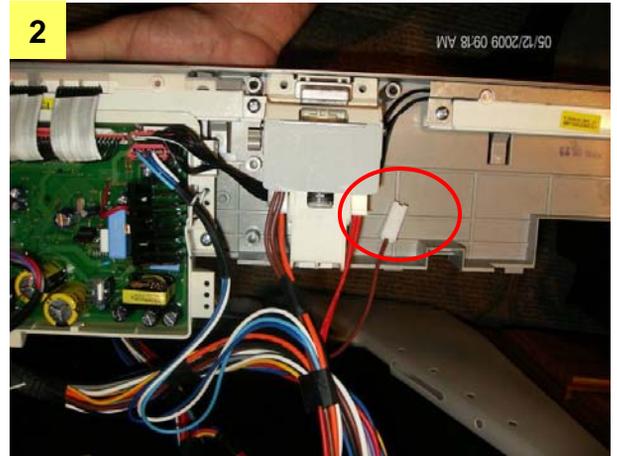
6) Micros switch loose connection

What was seen when the panel was removed This is a better view of the disconnected wire

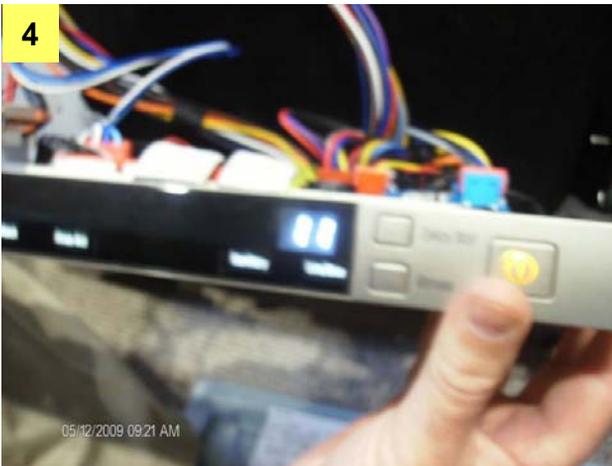
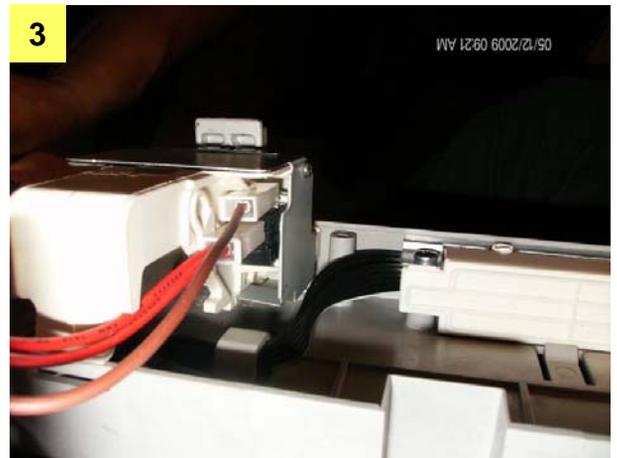
The unit is now responding to SC test normally The connector was reinserted back into place

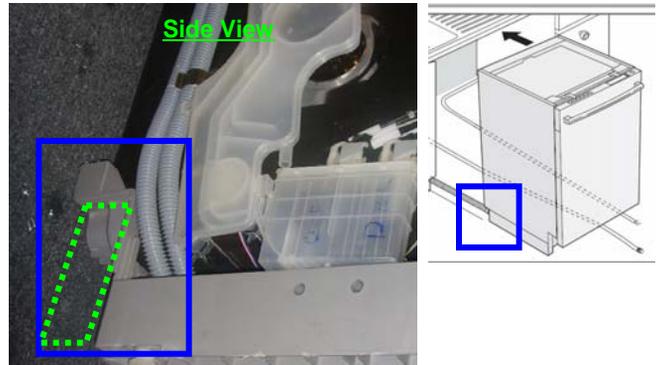
2) Drain hose kinked by bad installation [Installation]

6 3/4" (171 mm)

Water supply hose, drain hose and electric cable should be passed through this area

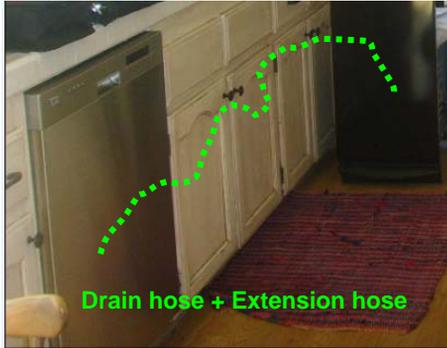
3) Too long extension hose (over 6ft, installation)

.If the length of extension hose is longer than 6ft,
Can not drain water properly
→ Make the length of extension hose shorter than 6ft
Sink pipe

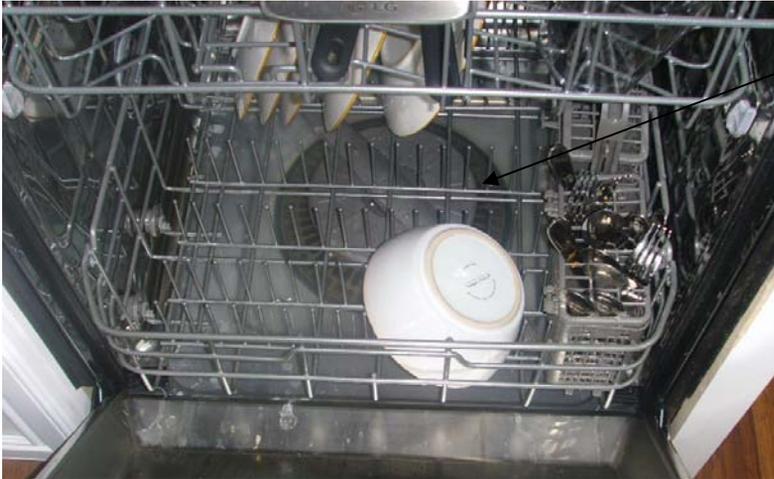
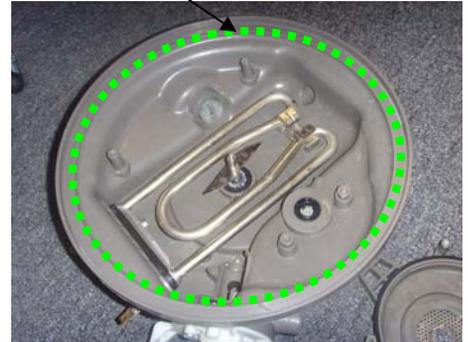
6) Drain pressure drop from the gap in drain cover ,can happen serial no : 612~711

- . Drain pump operation (No problem)
- . We can see some water is drain to drain hose, sometimes Not OE error but too much water remain
- . But after drain process, there is too much water remain in the sump assembly (800cc ~ 1000 cc)

Water remain near by sump filter hole

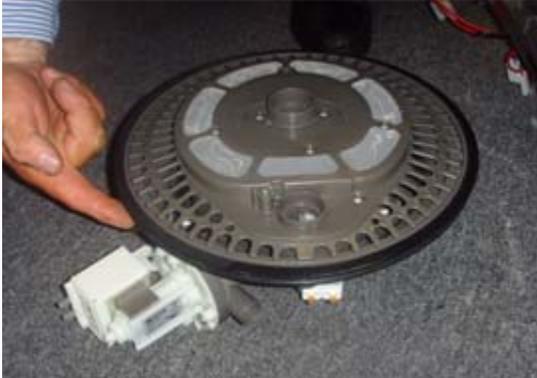
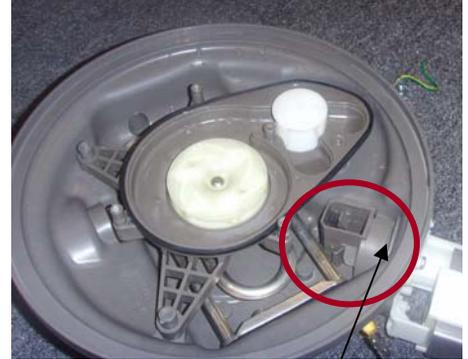
→ Replace sump assembly (S/no: 901~, production date is from 2009.1 ~)

If the Gap between drain pump case ~ drain cover is too much, drain pressure would be drop down. So not drain, too much water remain in sump

→ New (No gap : S/no 901~)

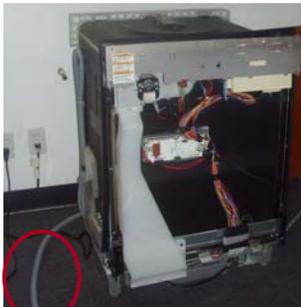
✓ **1) Water automatic drain out by siphon effect [Installation]**

→ Check the drain hose, If the end of drain hose location was below than 10"(250mm) or deep into the water pipe, the water can be drain out automatically and make air sucking noise [S/no 901~, we improved this issue by applying siphon protect, but not perfect]

Lie drain hose on the floor
 → Hose position is below than 10"(250mm)

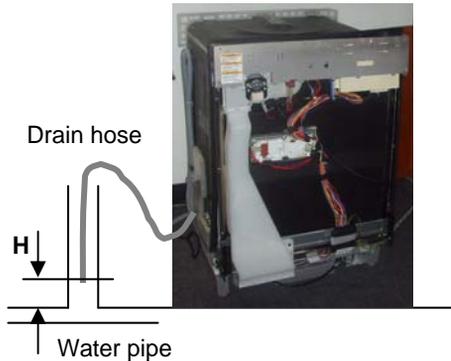
Change the end of drain hose position Over 10" (250mm) and fixing

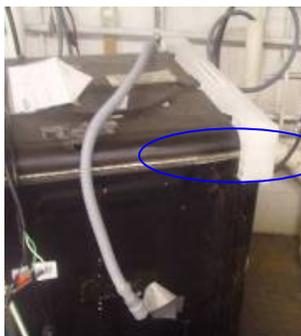
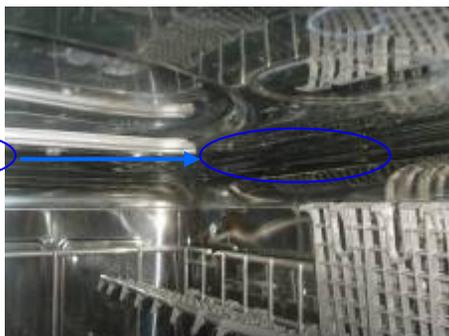
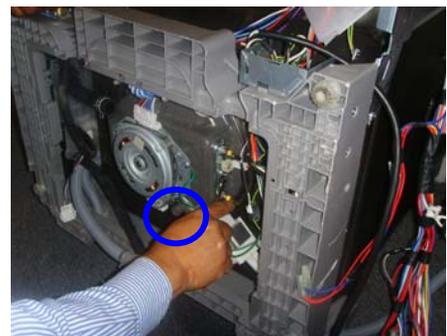
2) Logistic damage (Inner area broken or leakage)

→ Check the damage or leaking in Tub or Bottom sump area.
 : If the parts are broken, replace the parts, but tub damage, we can't repair

→ Check sump after service, miss hose connecting
 : Reconnecting hose

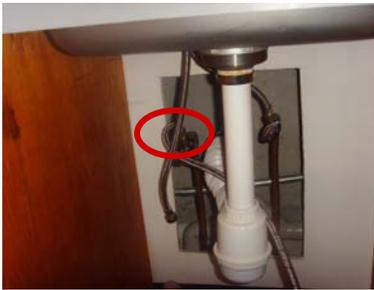
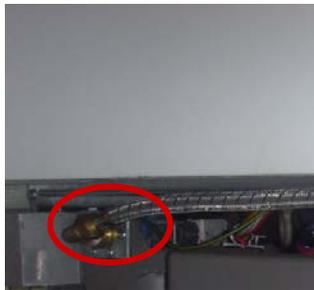
✓ 1) Water condition

Check that there is much steel stain powder or other dirty material in water pipe especially new house or after remodeling. This tiny material can block a small hole in inlet valve, if then even though no power supply to inlet valve, the water supply is going on infinite until locking water tap.

- Disassemble water supply connection between water supply hose & water tap
 Open the water tap fully, and hold on for 1 minute or until you can see clean water, and assemble again.
- Disassemble water supply hose with inlet valve
 Open the water tap fully, and hold on for 1 minute or until you can see clean water, and assemble again
- Next : Clean or replace inlet valve [Next step]

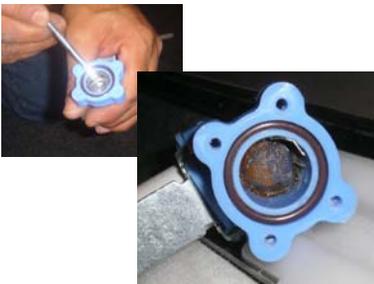
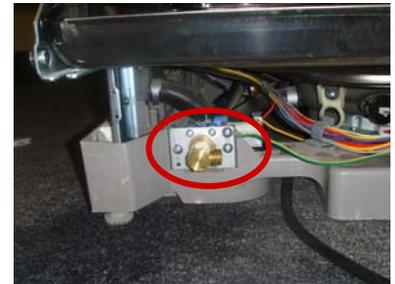
2) Clean or replace inlet valve (Recommend replace inlet valve)

Remove filter in inlet valve

Wash inlet valve

Replace inlet valve

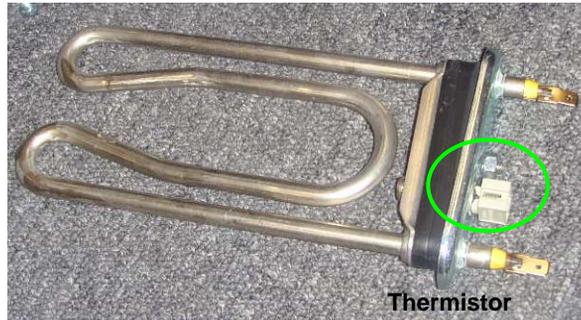
Heater assembly

Pull D/W from sink cabinet and Replace the heater assembly

→ Replace the heater assembly or Sump assembly

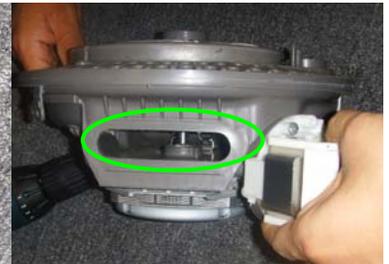
Thermistor

Heater assemble area
In Sump assembly

★ if only thermistor has problem, change heater assembly.
not replace only thermistor

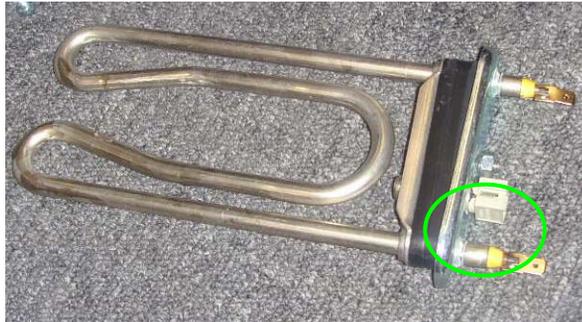
tE means that Main board doesn't check the resistor of thermistor in heater assembly

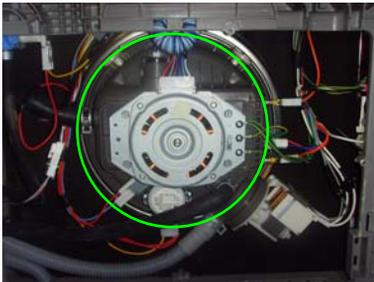
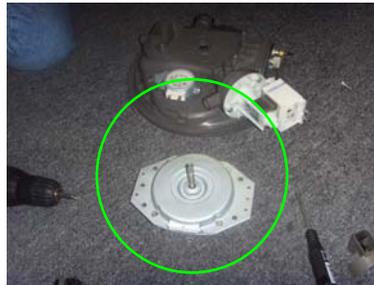
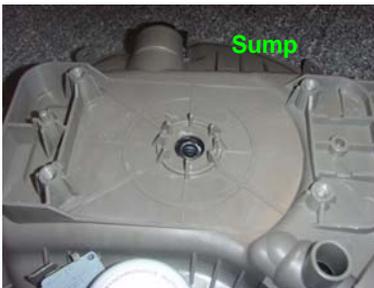
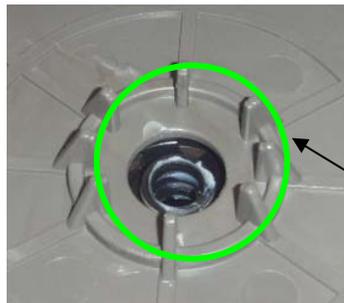
1) In test mode , washing motor doesn't rotate

→ Change washing motor

After remove bad washing motor ,
You must check the water seal condition.
If it's not good! Change sump assembly

! You must see the white grease is in Water seal

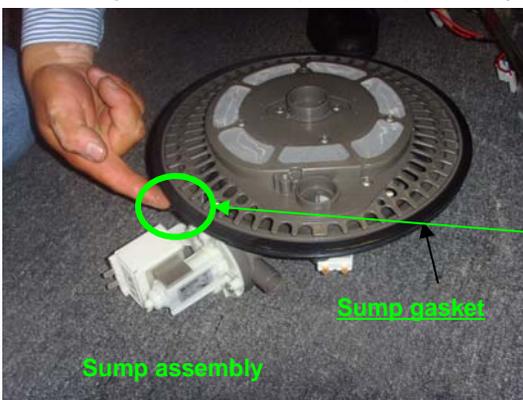
2) In test mode , washing motor doesn't rotate

→ Change sump assembly [Not only Washing motor but also Water seal have problems]

! Must use new sump gasket for perfect sealing
Don't use the gasket in old sump assembly, when you change sump assembly

! Must add some lubricant liquid to out area of sump gasket for better replacement (hand wash liquid detergent or ...)

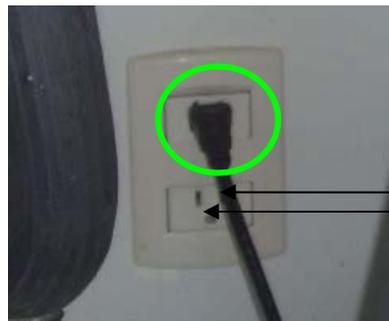
<3> Check the electric outlet

Check power supply

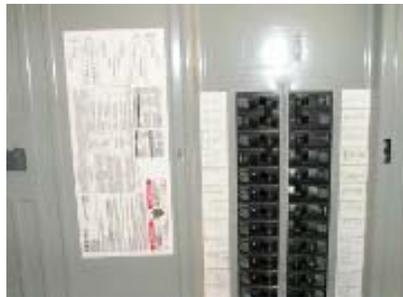
<1> Check the circuit breaker S/W : On / Off

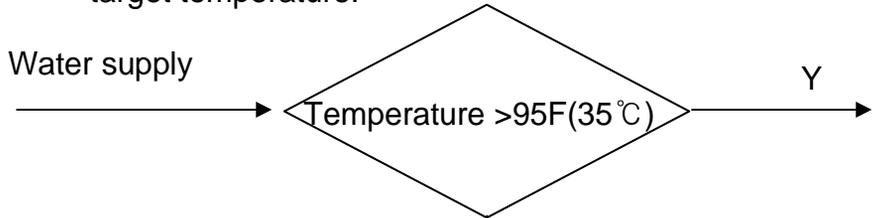
In cold water supply condition, after water supply process Heater heat the water to 95F (35°C). At this time washing motor runs for 1 minutes when the temperature rise up every 9F(5°C) by target temperature.

➤ Only Pre wash process

Temperature	70F	79F	88F	95F
Heater	ON	ON	ON	Off~
Washing Motor	Off	On for 1 min	On for 1 min	On~

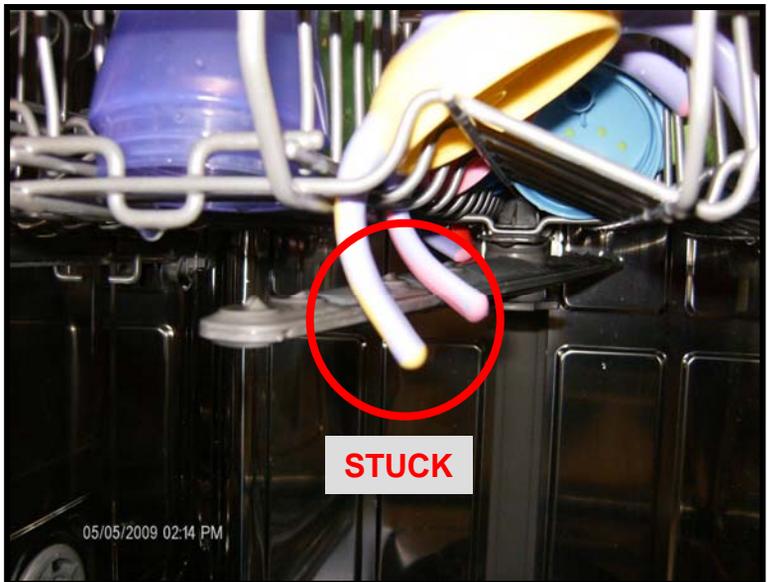
- Low spray arm's holes for washing filter is blocked
- Upper spray arm is stuck by hard soil or sand so very difficult to rotate
- ✓ ▪ Top small spray arm is stuck by hard soil or sand so very difficult to rotate
- Spray arms were stuck by cup or cooking tools

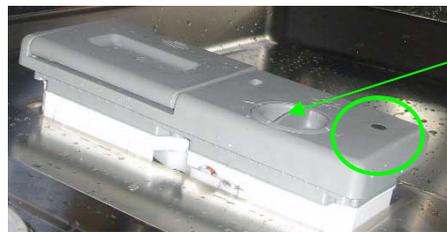
Chamber for rinse aid

- Recommend the customer use “Rinse aid” for good drying performance
- Check the quantity of rinse aid in dispenser by using indicator in control panel or circle glass window on dispenser (Dark: rinse aid is in the chamber, clean: Empty)
- The function of rinse aid in drying system
 - . Reduce the surface tension of water so the water drop on dishes or cups can be spread not into a ball → very easy condition for evaporation
 - If the customer don't use rinse aid, it's impossible good drying performance and water spot on glass and dishes.

Circle glass window :

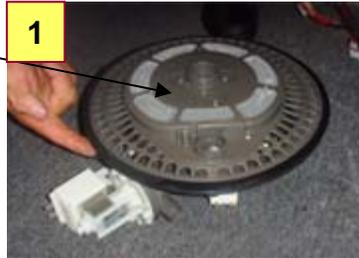
Sump : don't need remove sump assembly from the unit to remove sump cover

Sump cover →

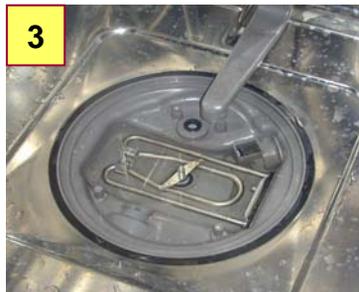
Remove sump cover

Remove pump casing & find out hard soils

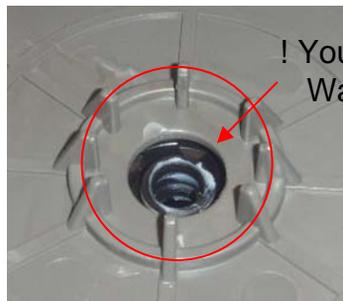
Whistle noise

- In washing cycle, the whistle noise is continue
- This means that there is some problem in water seal.
- Change sump assembly

! You must see the white grease is in Water seal

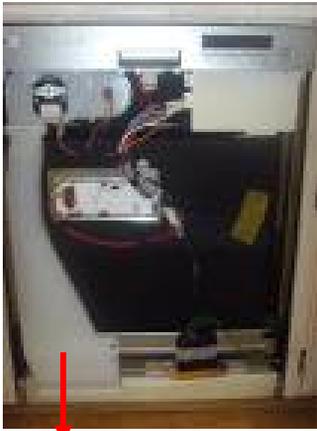
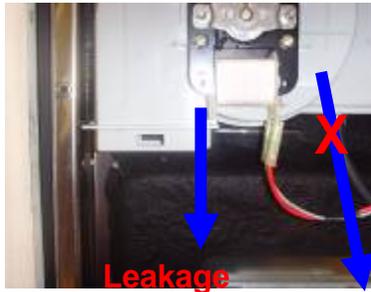
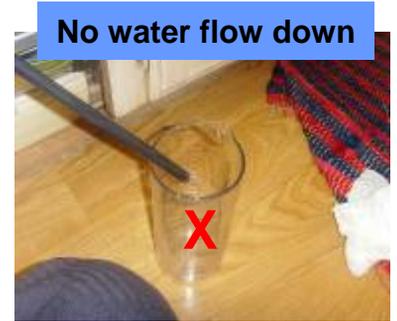
Vent leakage

- if we can see the water leakage at the end of vent, change blower assembly (s/no: 809~) or make a hole bigger Φ 5.5

Reason : Hard water residue block the rubber hose pipe

Leakage

No water flow down

Rubber hose

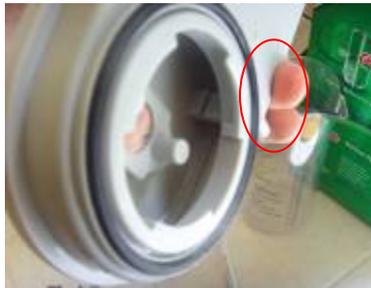
White film block the hole

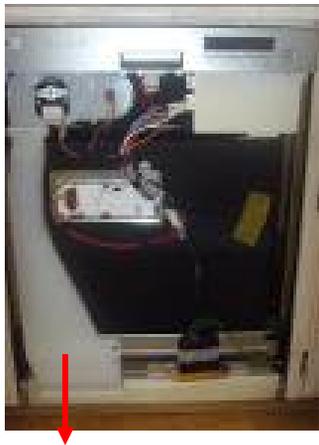
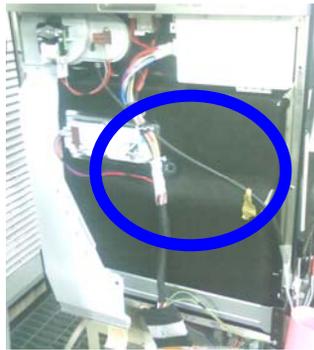
Vent leakage

- if we can see the water leakage at the end of vent, check the rubber hose position and reposition the rubber hose.

Leakage

Reason : If the rubber hose position is like below & Right, this can make a leakage

OK

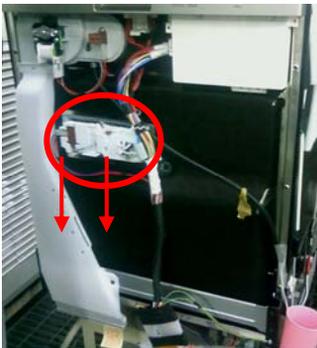
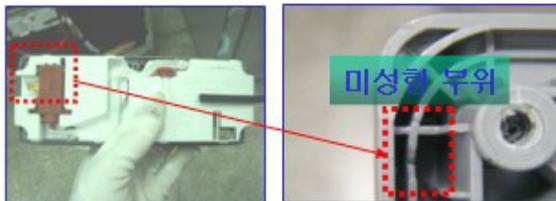
Dispenser leakage

- if we can see the water leakage between dispenser & door liner, Replace the dispenser

Reason : Bad shape in sealing area

Solution : Replace the dispenser

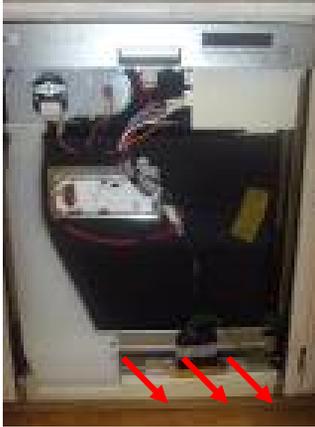
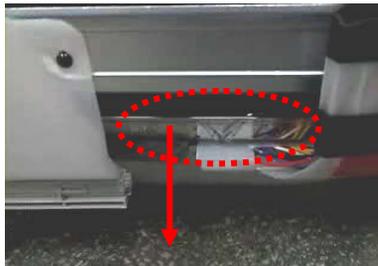
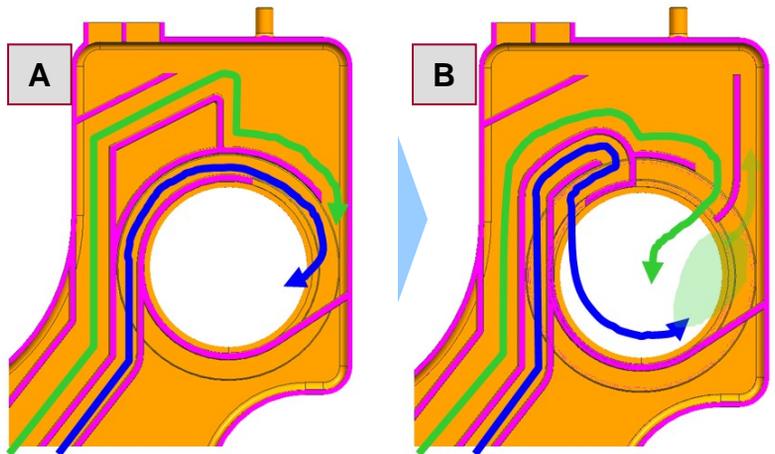
Door leakage

- If a lot of water leakage below the door not vent, especially hot water condition, Change air guide assembly to protect leakage revival

Reason : High air pressure in the tub .

Solution : Exchange air guide assembly
A → B (S/no: 902~)

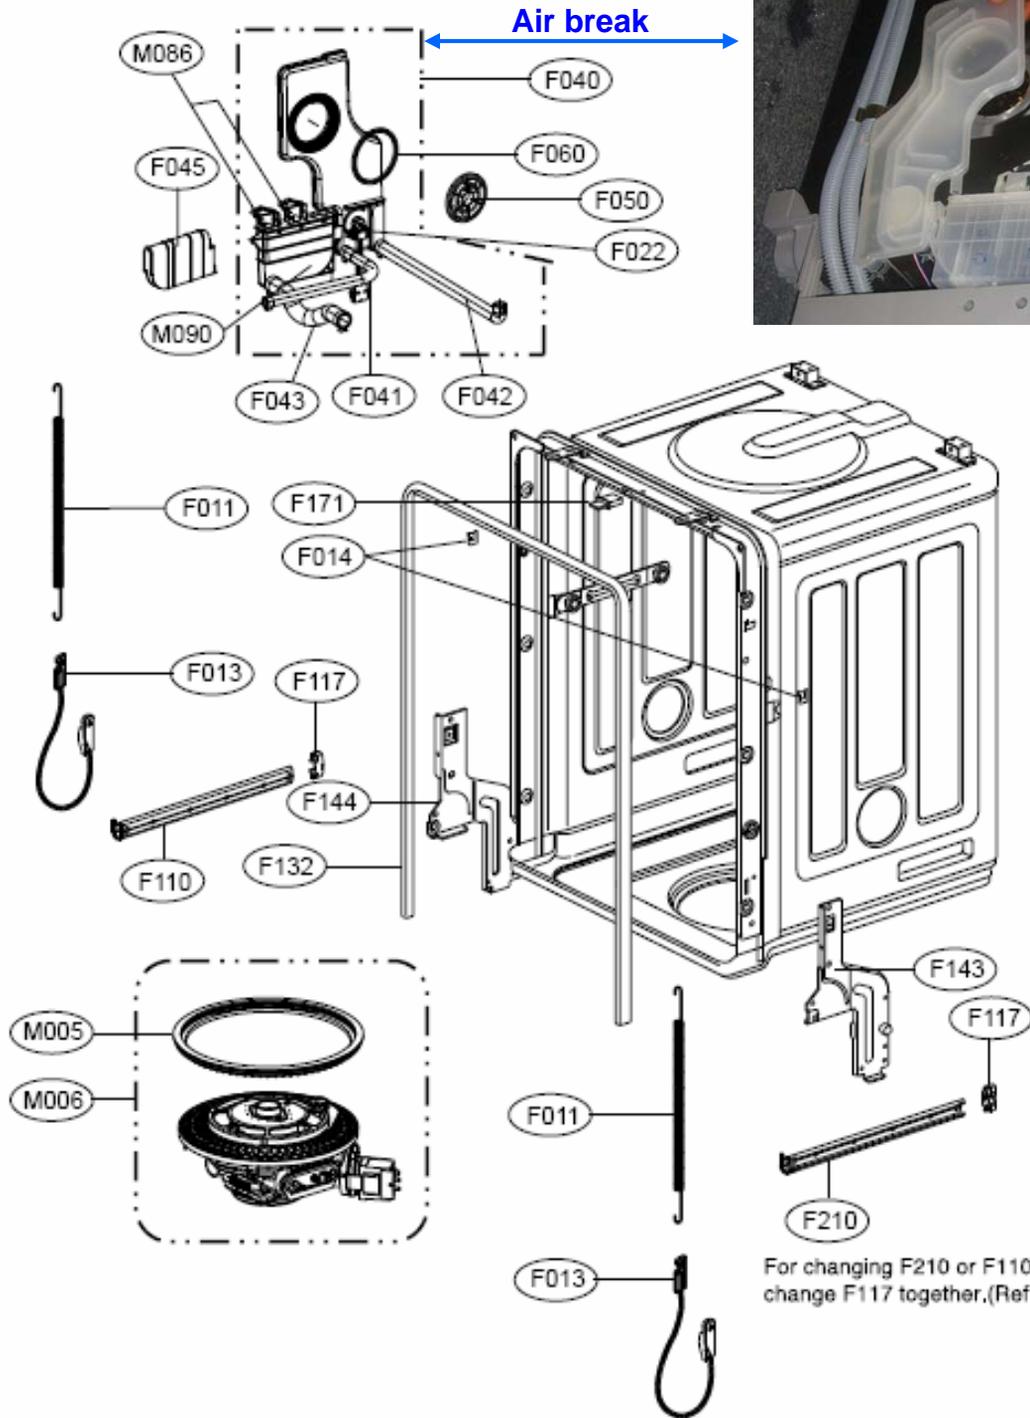
4. Exploded view

For changing F210 or F110, you must change F117 together.(Ref 32page)

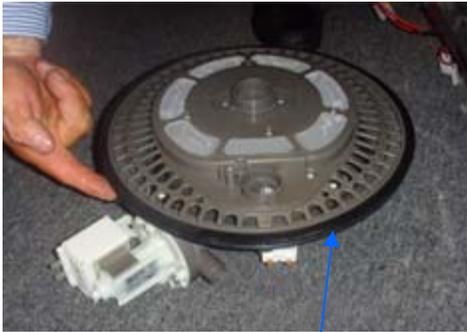
* Sump gasket : Refer to Page 31

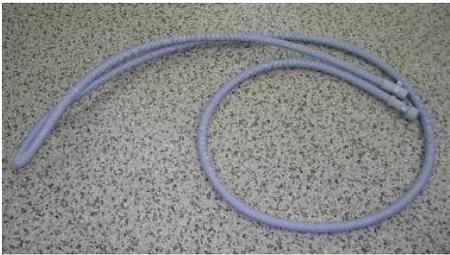
LOC No. and Description	BEFORE (S/N : 501KW#####~810#####)	AFTER (S/N :811##### ~)
A130 Drain hose	AEM30700301

AEM69493801

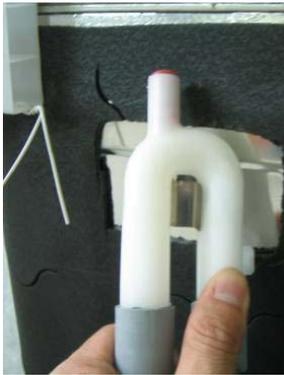
1) There are 2 methods of mounting the siphon break. For bracket installation follow step "a". For wire tie installation follow step "b".

a) Insert the right side of the siphon break under the bracket as shown below.

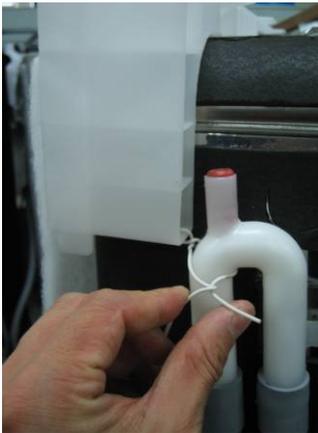
b) Use the existing wire tie from the previous hose to support the siphon break and hose

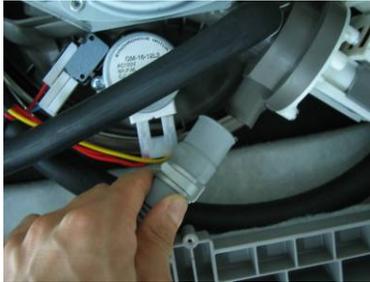
3) Attach the drain hose to the drain hose outlet on the sump using the clamp provided. Clamp is included with the new hose.

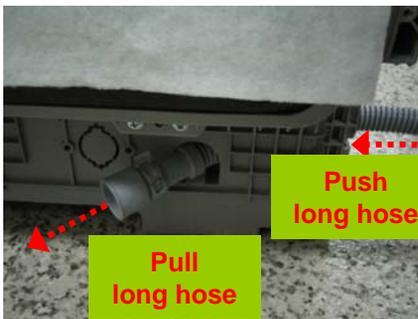
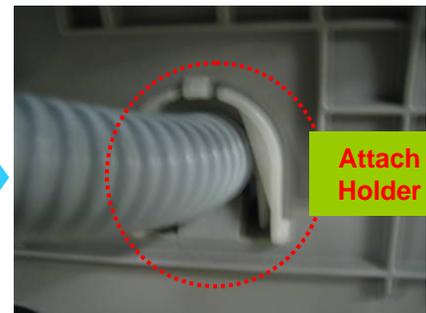
4) Feed outlet end of long hose through the hole in the back of the base and attach bracket holder. Check to make sure hose is not kinked or twisted.

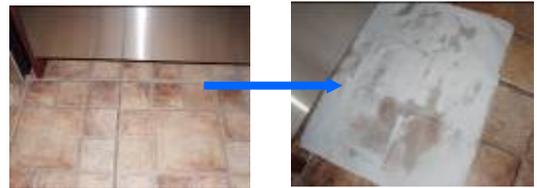
**2.Solution : Redesigned vent to prevent
condensation build up on floor.**

3.Changed parts

LOC No. and Description	BEFORE (S/N : 712KW#####~812#####)	AFTER (S/N :901##### ~)
K124 Vent	MJZ39902101

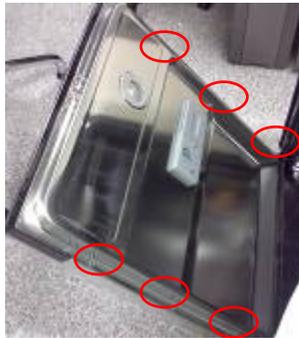
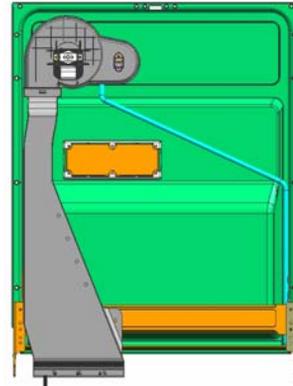
a) Remove front door by unfasten 6 screws

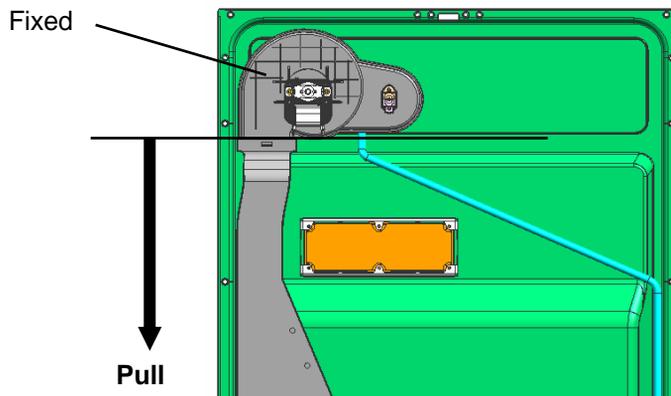
c) Remove old vent from blower assembly by pulling down.

Note: Only the vent should be removed, motor assembly is fixed and it should not need to be removed for this process.

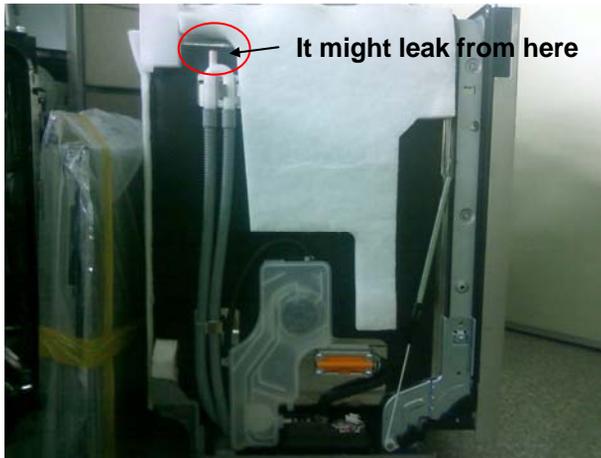
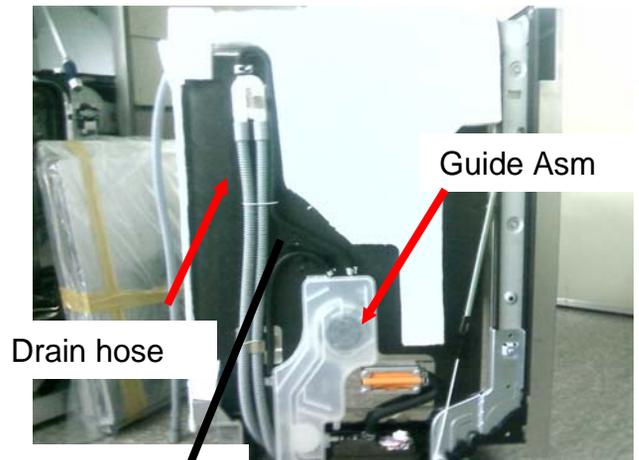
If you need to repair the Drain Hose Asm, The drain hose Asm& Guide Asm (Loc# : F040) must be changed together. Otherwise it might make leakage from the Drain Hose Asm.

Before

After

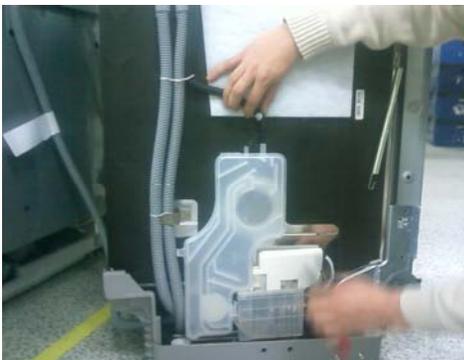
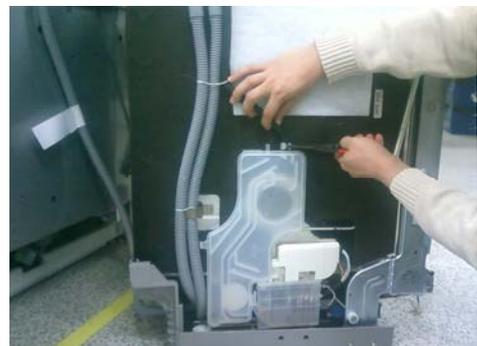
This additional hose must be connected in Guide Asm (4975DD1001*, Loc # : F040) as shown below.

3) clamp the drain hose into Guide Asm .
It prevents leakage from drain hose

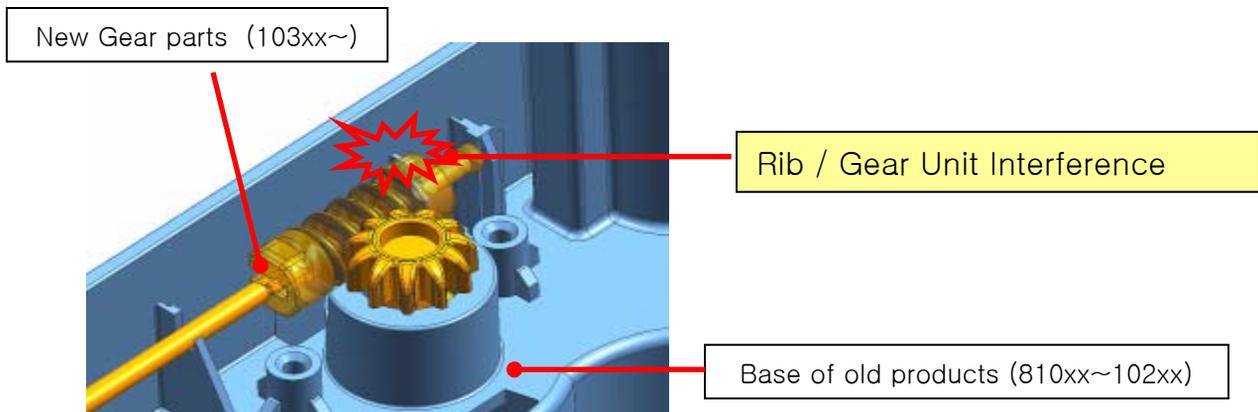
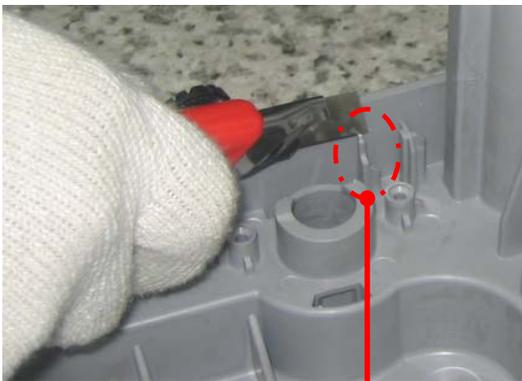
Compatibility of new worm gear system with old base

To use the new worm gear parts on the old base you will need to modify old base to allow for clearance.

- Put gloves on to prevent injury
- Using a utility knife, remove the rib located on the back side of the rear foot hole (as illustrated above).
- Note: If replacing both rear feet worm gears the rib will need to be removed from both sides.

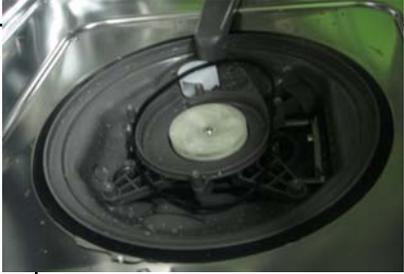
<p data-bbox="408 523 625 643">Be careful to fix O-ring correctly</p>

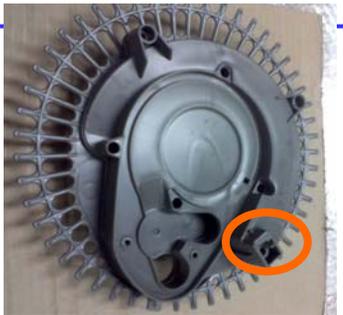
<p data-bbox="44 1286 1339 1335">Must check your service part is correct (It must have guide Rib like below)</p>
