**VIKING PREFERRED SERVICE**

# SERVICE BULLETINS

## **Service Bulletin**

### **DAMAGE TO COSMETIC , TRIM AND PAINTED SURFACES**

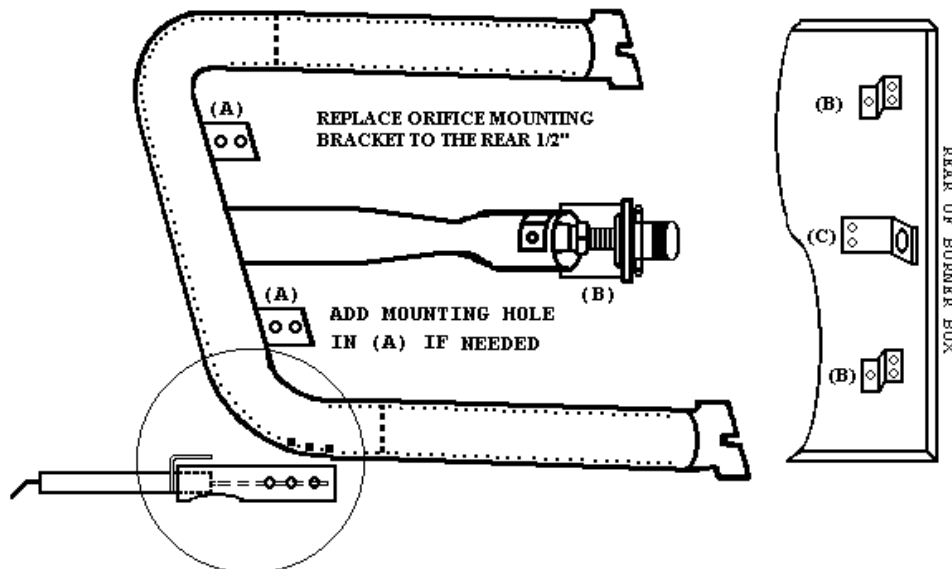
ILLUSTRATION #3

To Correct Burner Shut-down During Normal Operation.

Alignment of the igniter electrode in the blue tips of the inner cone at the three burner ports (located below the regular burner ports) will keep the gas valve open, preventing shutdown.

- Correction:**
- (1). Replace the Orifice mounting bracket "C".
  - (2). Add another mounting hole in oven bottom for burner bracket "A".
  - (3) Add new Brackets "B" from kit.

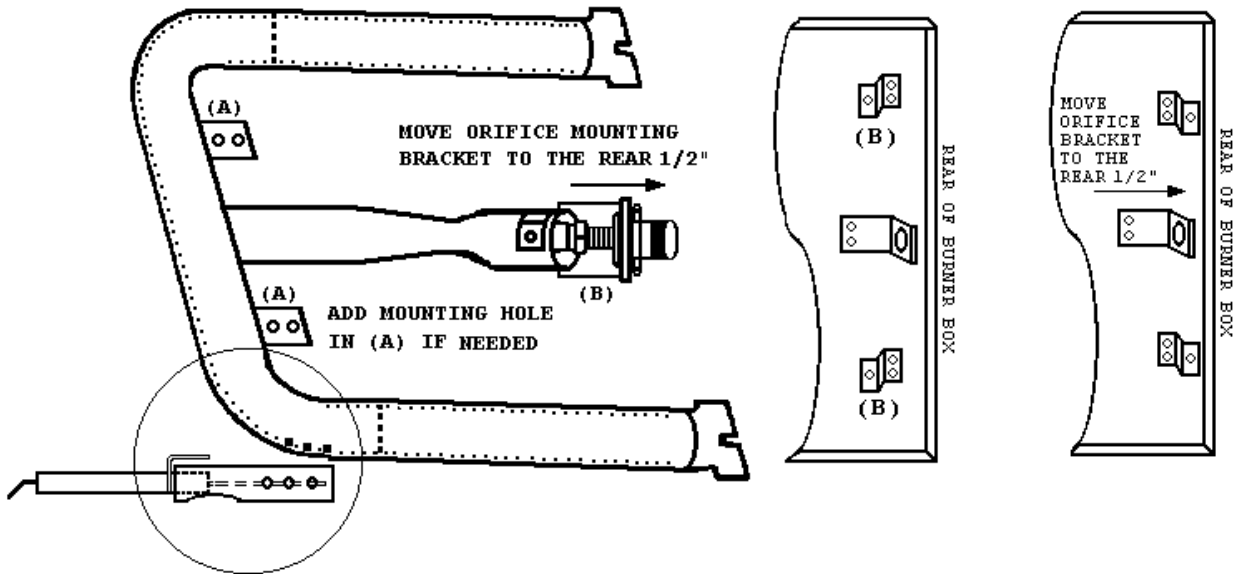
ILLUSTRATION #3

To Correct Burner Shut-down During Normal Operation.

Alignment of the igniter electrode in the blue tips of the inner cone at the three burner ports (located below the regular burner ports) will keep the gas valve open, preventing shutdown.

- Correction:** (1). Reverse the burner mounting “Z” brackets (B).  
(2) Add another mounting hole in bottom of oven to mount bracket (A).

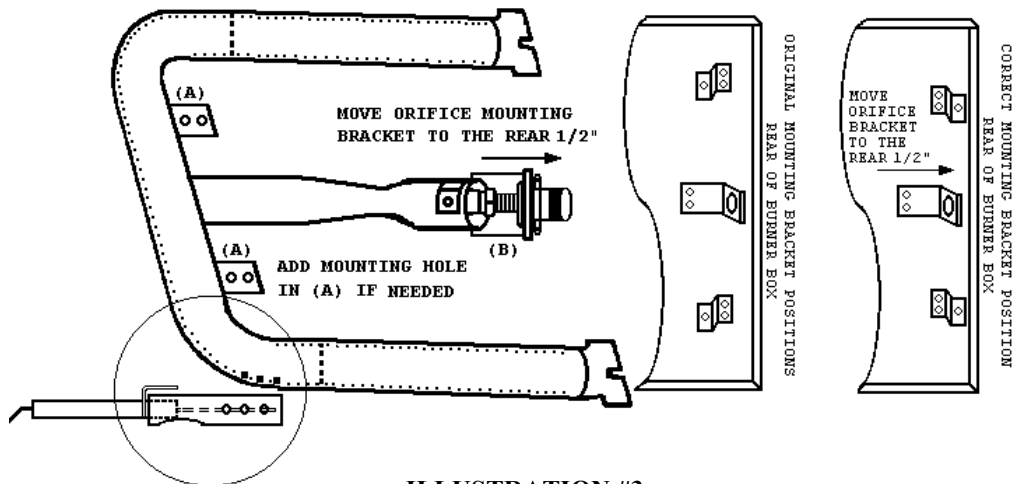
ILLUSTRATION #3

To Correct Burner Shut-down during Normal Operation.

These corrections will move the burner onto the orifice hood for better gas/air adjustment. Alignment of the igniter electrode in the blue tips of the inner cone at the three burner ports (located below the regular burner ports) will keep the gas valve open, preventing shutdown.

- Correction:**
- (1) Inspect the position of the igniter electrode to the burner ports (A, B, & C). Illustration #1 is incorrect. Illustration #2 is the correct position.
  - (2) Reverse the burner mounting "Z" bracket (See Illustration #3 Below).
  - (3) Move the Orifice mounting bracket toward the rear 1/2" and remount.
  - (4) Add another mounting hole in bracket (A) if needed.

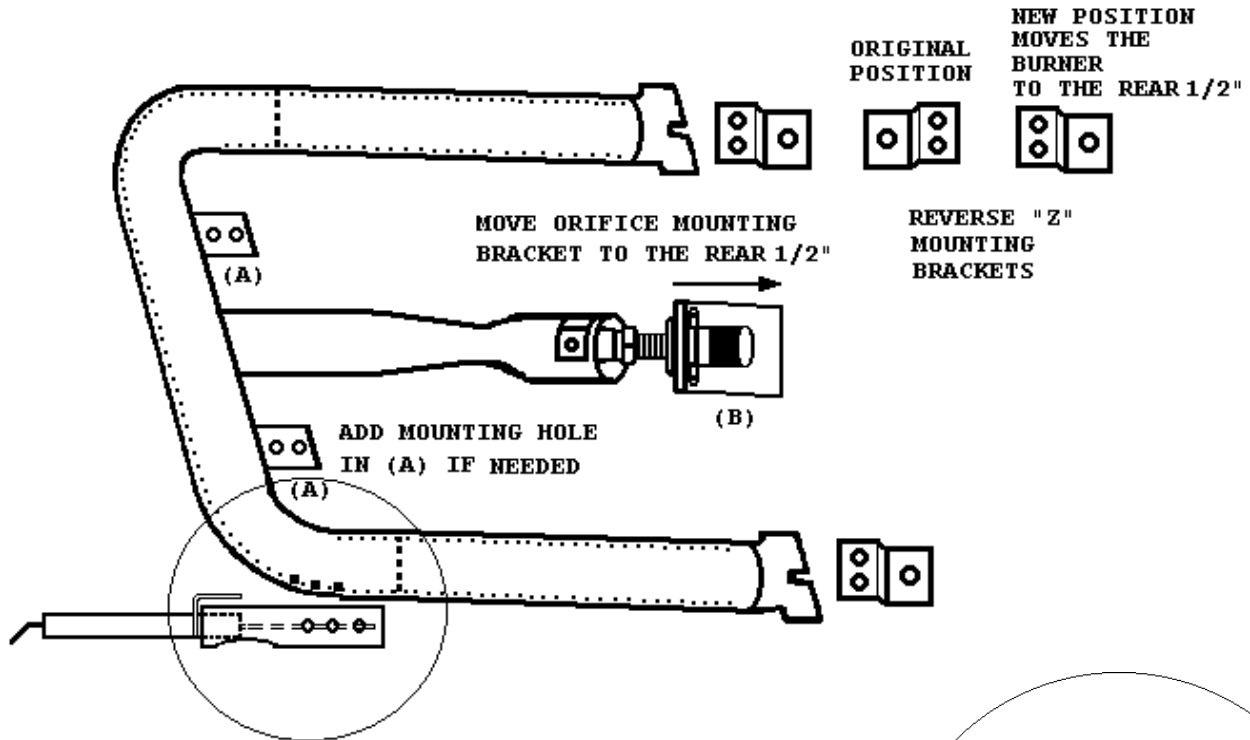
**Re:** To Correct Burner Shut-down during Normal Operation.

**THE IGNITOR ELECTRODE MUST BE IN THE TIPS OF THE INNER BLUE CONE AT PORTS "A", "B" & "C".**

- Correction:**
- (1) Reverse the burner mounting "Z" bracket (See Illustration below).
  - (2) Move the Orifice mounting bracket toward the rear 1/2" and remount.
  - (3) Add another mounting hole in bracket (A) if needed.

These corrections will move the burner onto the orifice hood for better gas/air adjustment. Alignment of the ignitor electrode in the blue tips of the inner cone at the three burner ports (located below the regular burner ports) will keep the gas valve open, preventing shutdown.

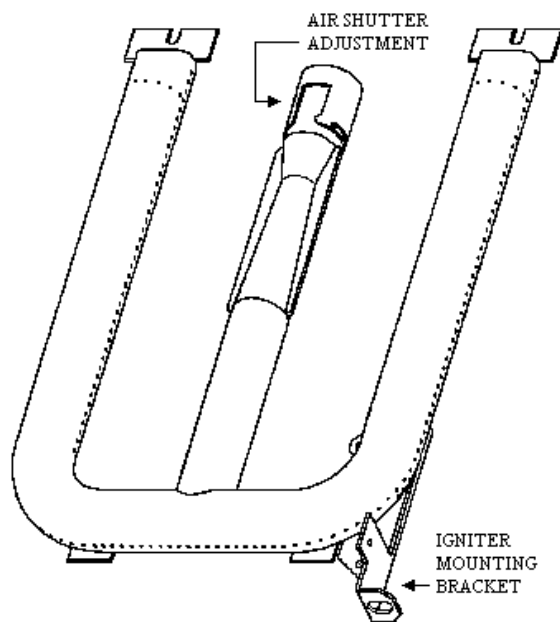
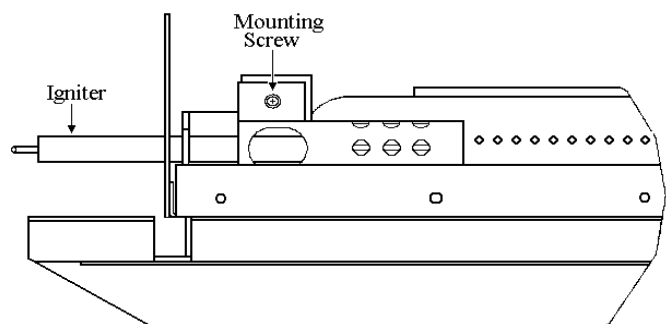
**Complaint:** Burner shutdown during normal bake operation and self-clean operation.

**Correction:** Install new Burner with welded igniter bracket:

1. Remove oven racks and rack supports.
2. Remove oven bottom pan assembly.
3. Remove burner cover.
4. Remove and save igniter for later installation.
5. Install new burner (with welded igniter bracket).
6. Re-install the saved igniter.
7. Replace burner cover and oven bottom pan assembly to check and adjust the air/gas mixture.

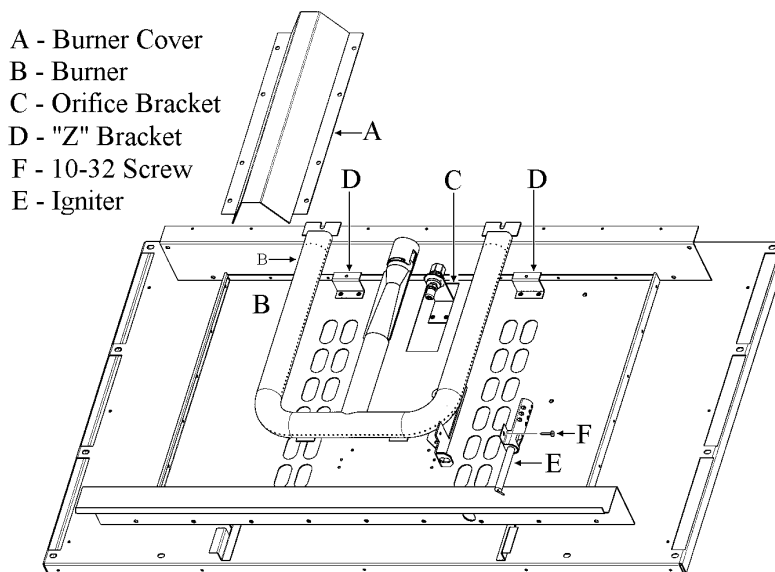
**Complaint:** Burner shutdown during normal bake operation and self-clean operation.

**Correction:** Install new burner with welded igniter bracket:

1. Remove racks and rack supports.
2. Remove bottom pan assembly.
3. Remove burner cover (A).
4. Remove old burner (B).
5. Remove igniter and igniter bracket (E) - (retain igniter for later use.)
6. Remove (2) rear "Z" brackets (D).
7. Remove orifice bracket (C)
8. Install new orifice bracket.
9. Install (2) new "Z" brackets.
10. Place new burner in position (**DO NOT MOUNT**).
11. Install igniter on burner using supplied SS 10-32 screw (F)
12. Mount rear of burner to "Z" brackets.
13. Drill 2 new holes in burner bottom for front brackets.
14. Re-install burner cover (A), bottom pan assembly, rack supports and racks.

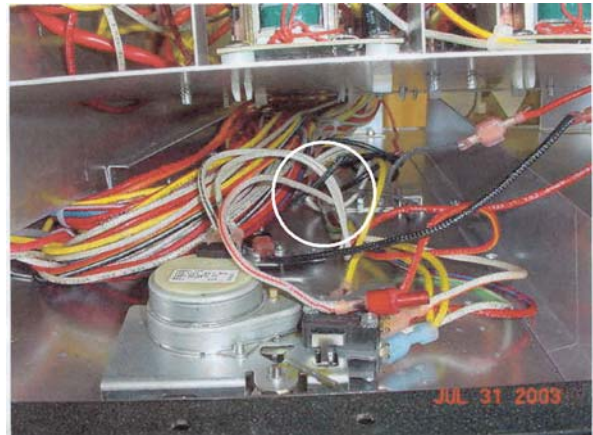
COMPONENT PANEL

Remove the **Control Panel**. Four screws at the top and six screws across the bottom (see drawing of the control panel.) Pull the **Control Panel** carefully forward and tilt up. Being careful not to disconnect wires attached to the components on the reverse of the panel.

The **Component Panel** is now accessible. Pull the **Component Panel** forward to release the panel from the slide. Lift the **Component Panel** up to gain access to the **upper (top) fan switch**.

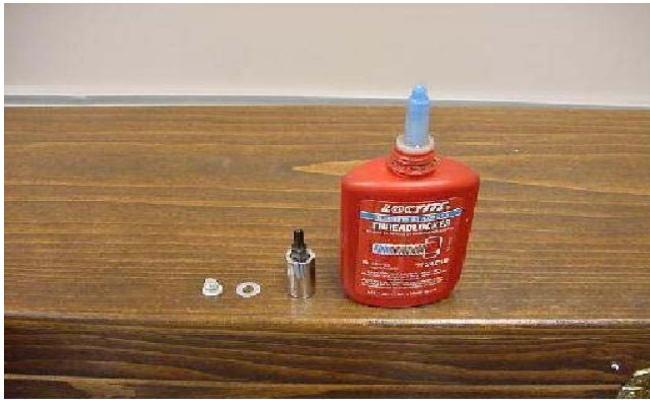
G5007240 Screw Repair Kit

**RE:** Preventing Hinge Screw from coming loose over time.

**Models:** VCBB 362 and VCSB 482

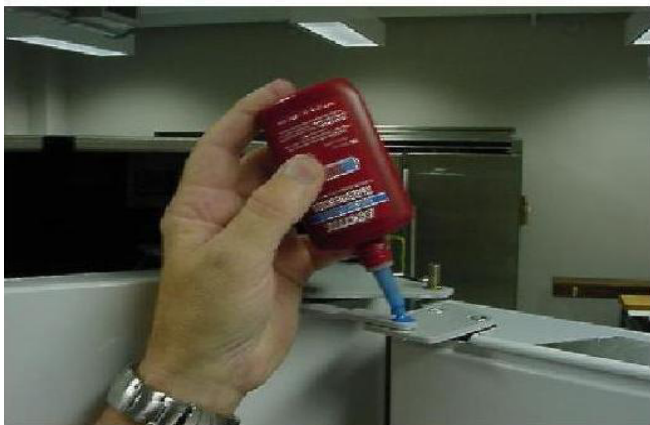
1. Loosen torx (T-15) screw one full turn.

2. Add Loctite (non-hardening) to top of screw.

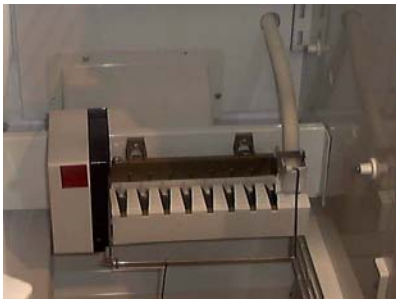
ILL. 1

- 1.) Remove the icemaker (Ill. 1).
- 2.) Clip the nylon tie that holds the molex connector in place (Ill. 2).
- 3.) Remove the icemaker support (Ill. 3).
- 4.) Remove the evaporator fan cover (Ill. 4).
- 5.) Locate the Bin Switch on the underside of the evaporator fan cover. (Ill. 5).
- 6.) Remove the wires from the bin switch and tie together with a wire nut. (Ill. 6).

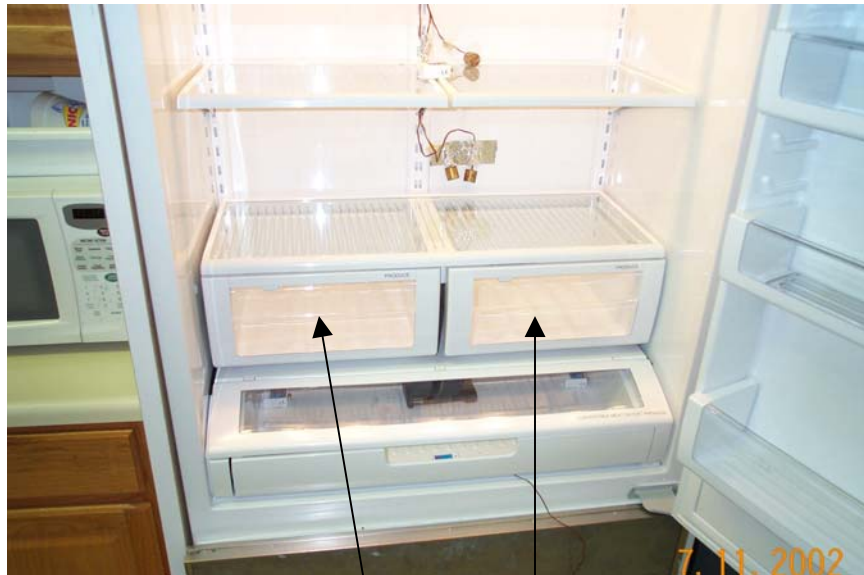
Crisper Pan Assembly-12056902

- 2) Remove Produce Drawers (Crisper Pan Assembly-12056902)

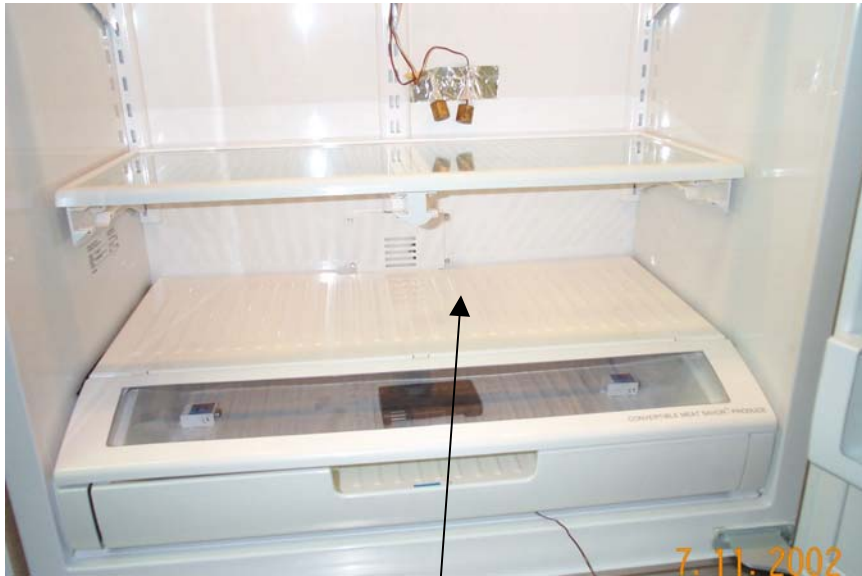
Deli Lid Assy-12223207 and Deli To

- 3) Remove Meat Savor Lid and Shelf (Deli Lid Assembly-12223207 and Deli Top Assembly-12223303).

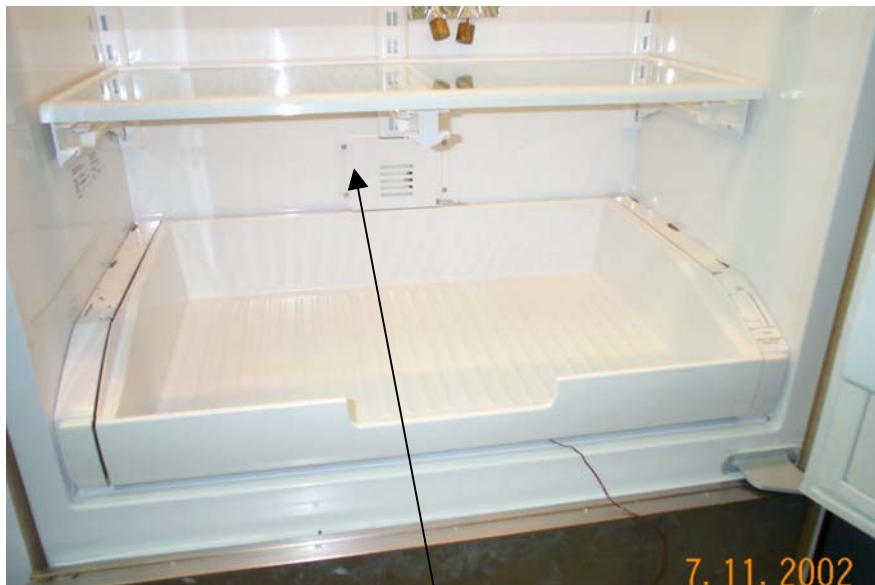
- 4) Remove Deli Control Cover (Cover-Deli Control-12073701)

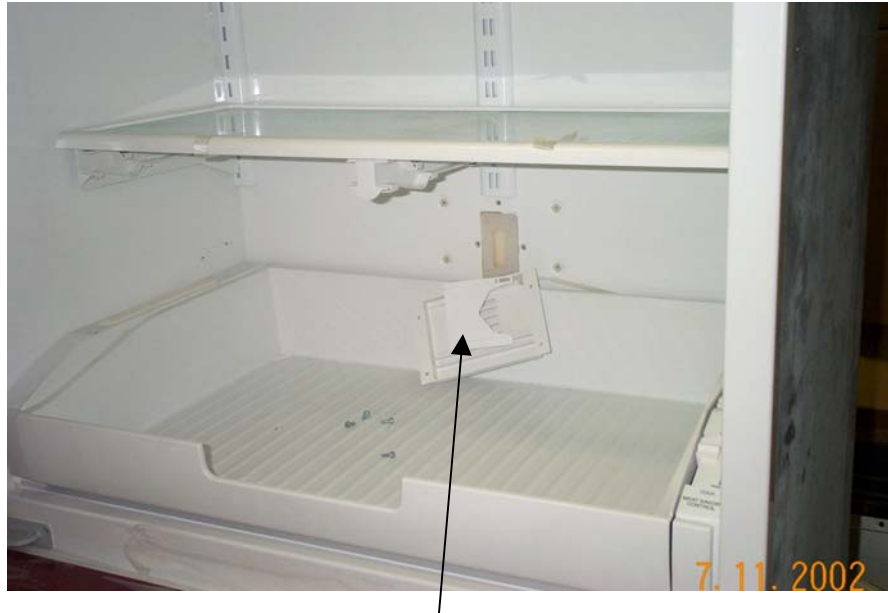
Slide-Deli Control-12073601

- 5) Disassembly Deli Control Slide from Deli Control Cover (Slide-Deli Control-12073601)

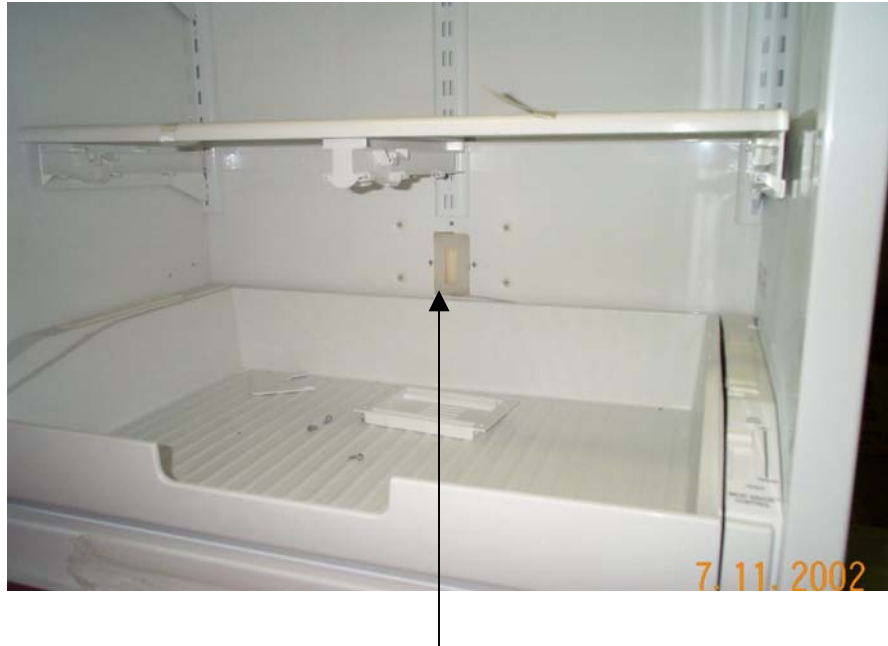
Duct Crisper Air - 10931801

- 6) Place Deli Control Restrictor (PM910292) onto Duct Crisper Air (10931801) using four screws (M0215704).

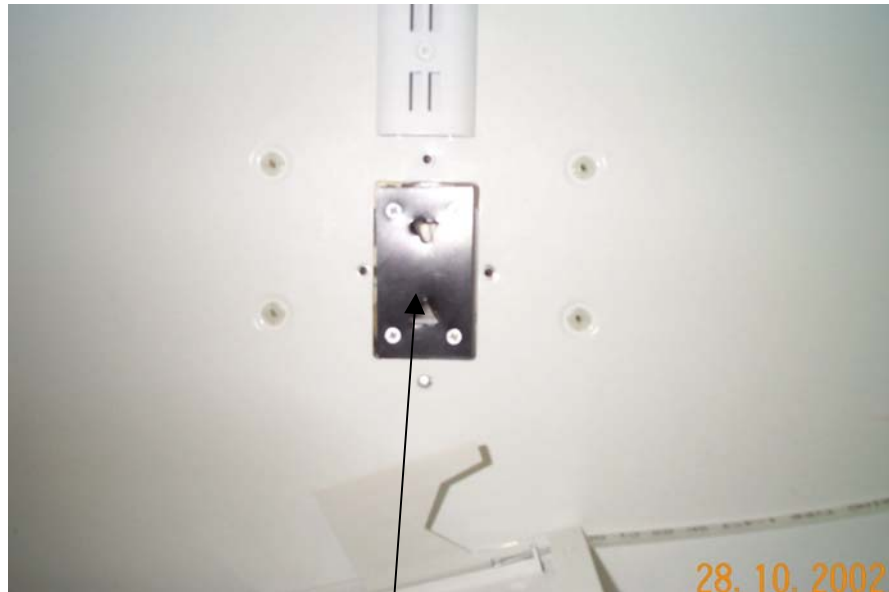
Deli Control Restrictor-PM910292

- 7) Place Aluminum tape along edges of Restrictor. Use 1.5" to 2" wide tape on the left and right sides and have 5/8" covering the sides. Use 1" wide tape on the top and bottom sides and have 1/4" covering the Top and Bottom.

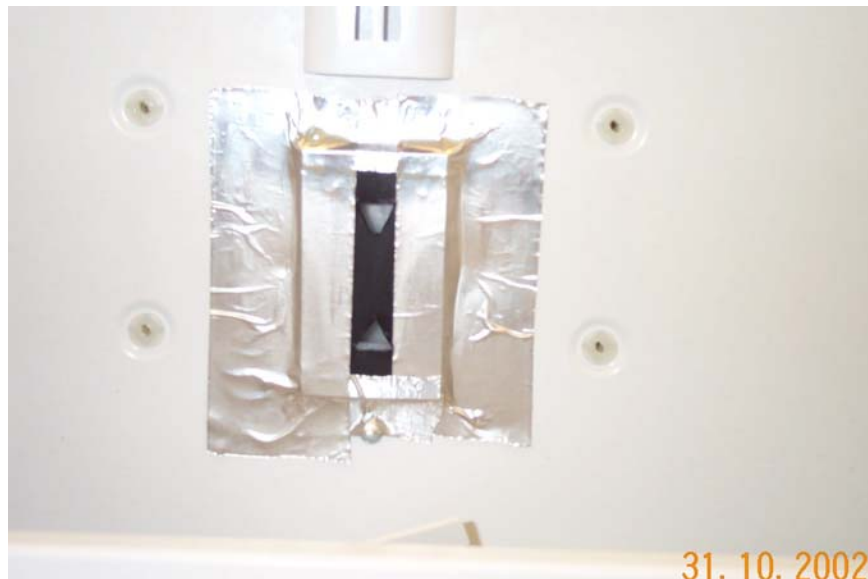
- 8) Place gasket material (PB970161 & PB970162) along edge of Meat Savor Glides.

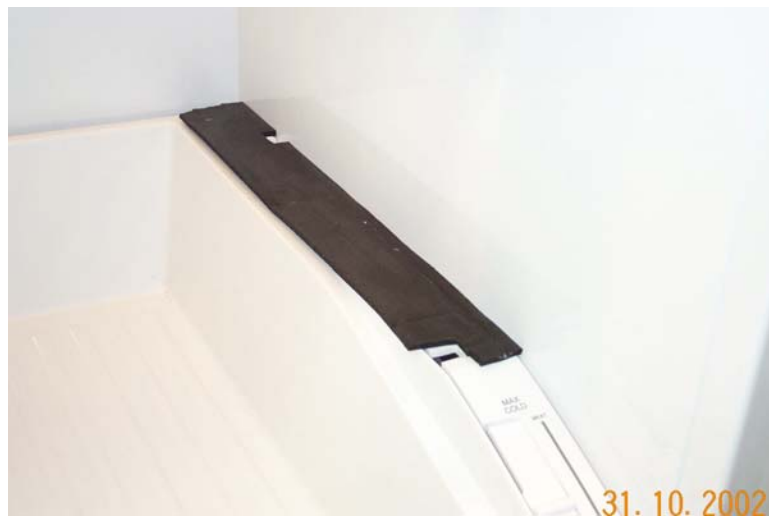
Right Hand Side

(PLEASE NOTE: Service Fix will have white gaskets)

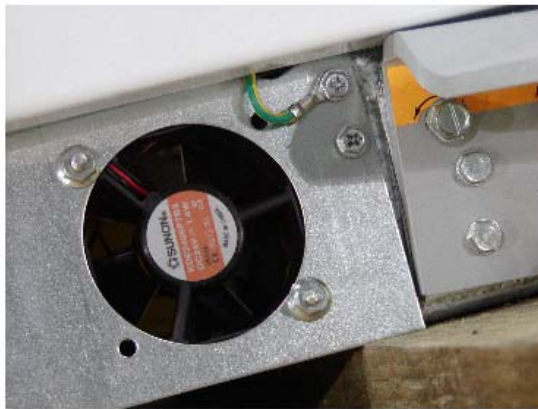
III 1

- Remedy: 362/363**
- 1) Remove the lower kick panel
  - 2) Follow the Red and Black wires from the condensate motor to the left. (Ill #2)
  - 3) Locate the Molex Connectors on the left side of the refrigerator and mate the two (C&D) together.
  - 4) Making sure the Green Ground Wire is secured in place.
  - 5) Replace the kick panel.

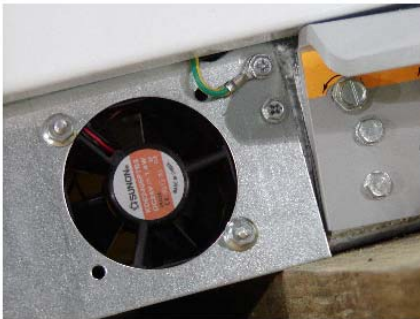
Ill #1

- 1) Remove the lower kick panel.
- 2) Remove the Condensate motor bracket screws A and B (Ill #3)
- 3) Locate the Molex Connectors (C and D) behind the motor bracket and mate them together. (Ill #4)
- 4) Replace the Condensate Motor bracket making sure the Green Ground Wire is properly secured.
- 5) Replace the kick panel.

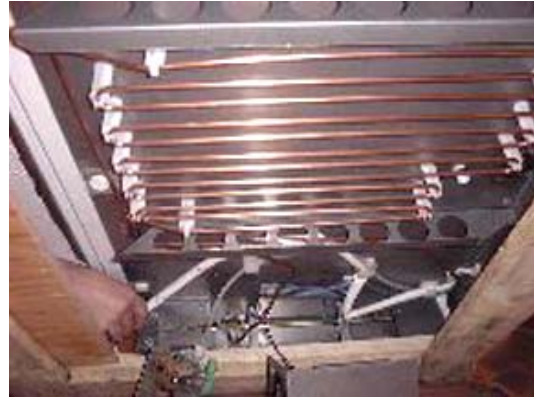
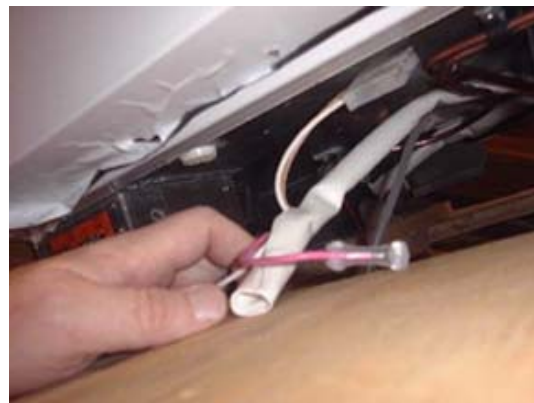
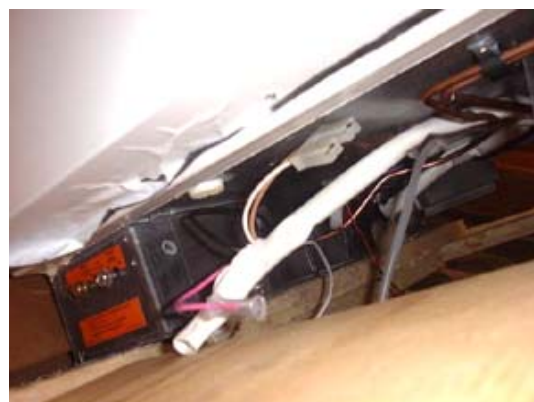
Heater – 120VAC – 28 Watts –  $661 \pm 7.5 \Omega$ .

1. Disconnect power to the unit using power switch.
2. Remove the toe grille (kick plate).
3. Remove the two (2) screws holding the water valve in place for access to the water valve wiring harness.
4. Remove the “L” shaped cover behind the water valve for easy access to the mullion heater wires (black and white).
5. Carefully slit water valve wiring harness vinyl sleeve to expose one black and one white lead with bullet terminals.
6. Locate mullion heater leads at the left side of cabinet and connect to black and white leads of the water valve terminators.
7. Wrap vinyl sleeve with electrical tape to close slit.
8. Reinstall “L” shaped cover the water valve.
9. Replace toe grille (kick plate).

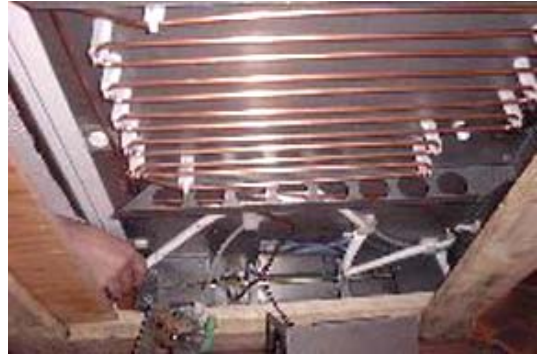
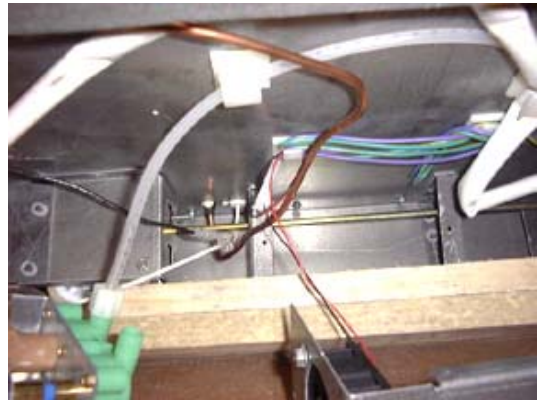
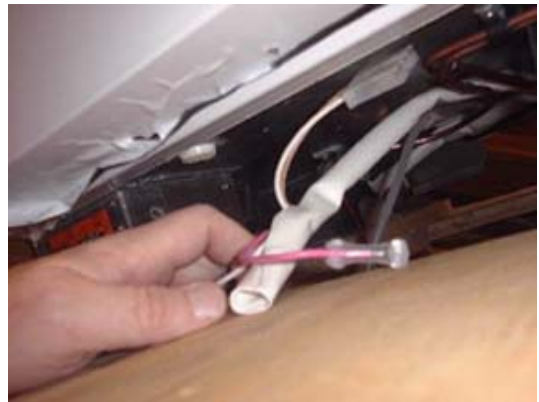
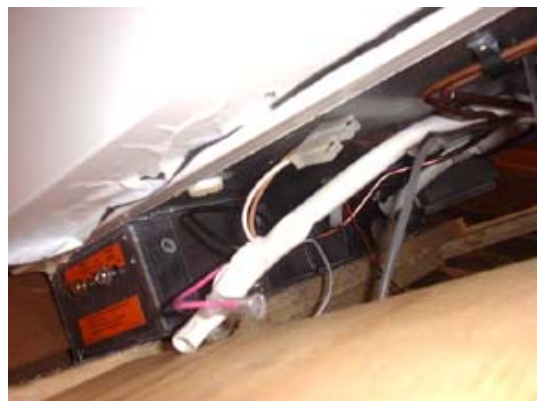
Heater – 120VAC – 28 Watts –  $514 \pm 30 \Omega$ .

1. Disconnect power to the unit using power switch.
2. Remove the toe grille (kick plate).
3. Remove the two (2) screws holding the water valve in place for access to the water valve wiring harness.
4. Remove the “L” shaped cover behind the water valve for easy access to the mullion heater wires (black and white).
5. Carefully slit water valve wiring harness vinyl sleeve to expose one black and one white lead with bullet terminals.
6. Locate mullion heater leads at the left side of cabinet and connect to black and white leads of the water valve terminators.
7. Wrap vinyl sleeve with electrical tape to close slit.
8. Reinstall “L” shaped cover the water valve.
9. Replace toe grille (kick plate).

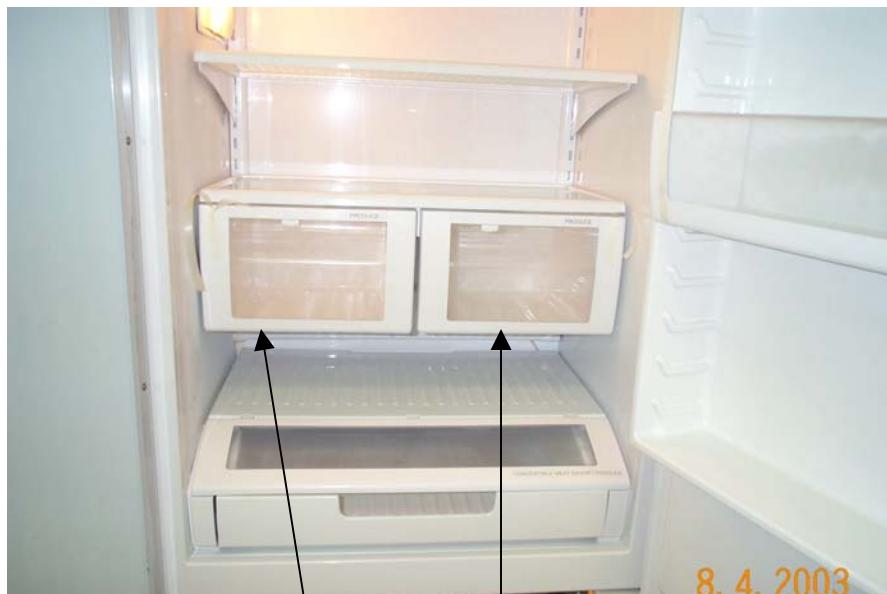
Crisper Pan Assembly-12144302

#### 2) Remove Produce Drawers (Crisper Pan Assembly-12144302)

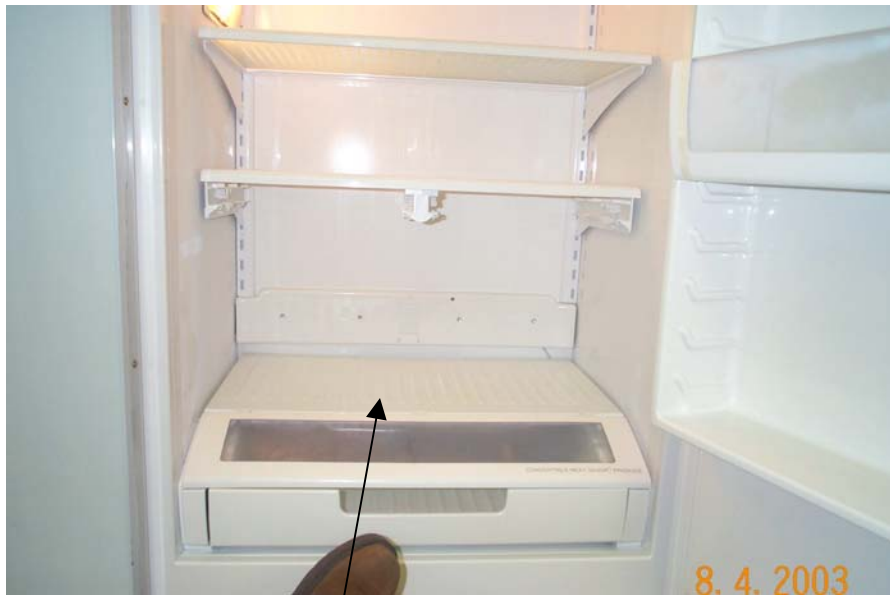
Deli Lid Assy-12223208 and Deli Top Assy-PK930044

- 3) Remove MeatSavor Lid and Shelf (Deli Lid Assembly-12223208 and Deli Top Assembly-PK930044).

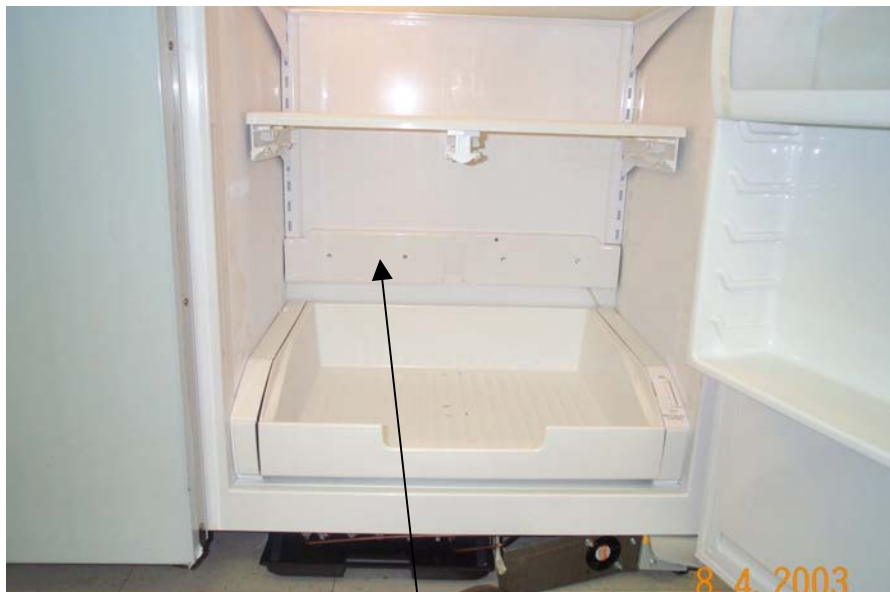
Cover-Air Control-12231201

- 4) Remove Air Control Cover (Cover-Air Control-12231201)

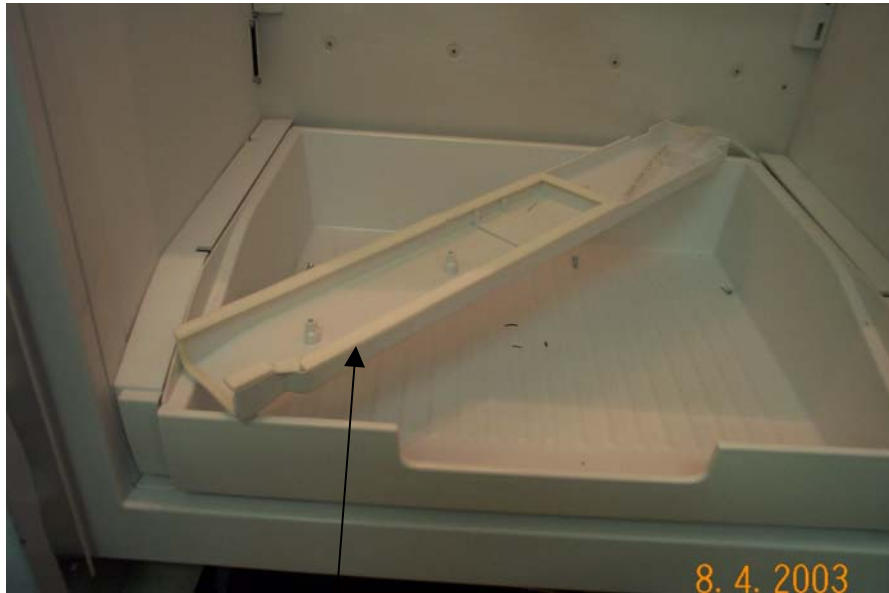
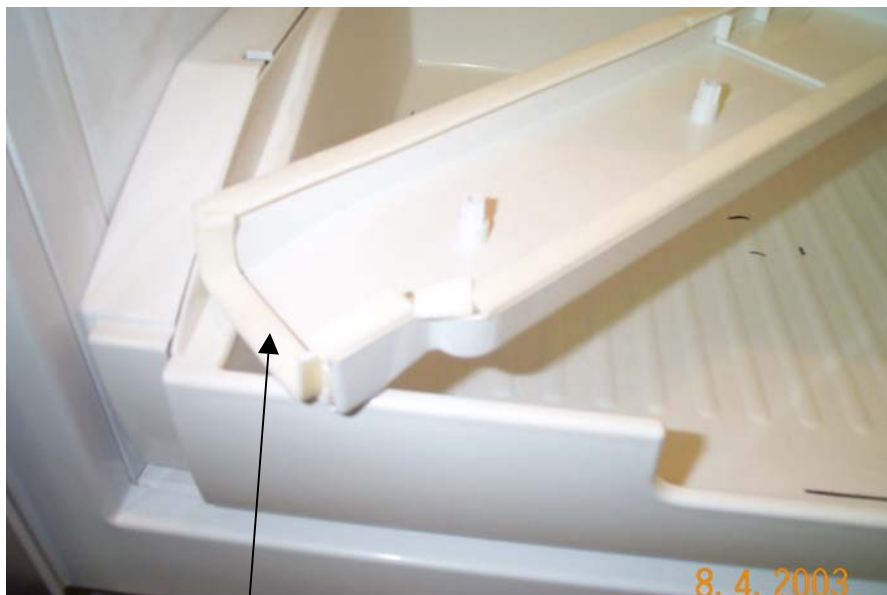
Gasket Foam-A3189348

- 5) Place Gasket Foam (Gasket Foam-A3189348) around the perimeter of Air Control Cover (Cover-Air Control-12231201)

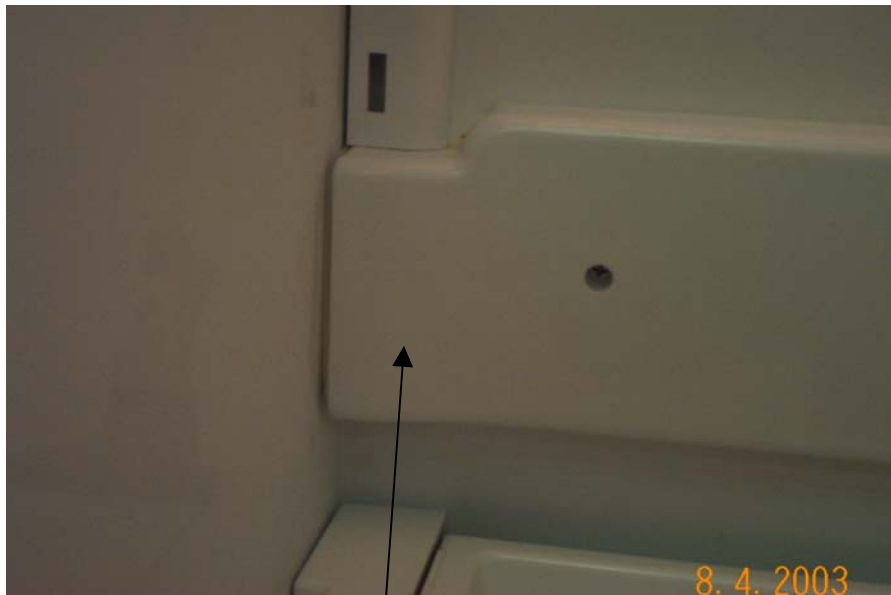
Cover Air Control-12231201

- 6) Reattach Air Control Cover (Cover-Air Control-12231201) to back of fresh food cabinet. Be sure to position Air Control Cover as far to the left as possible and tighten screws all the way so that gasket around perimeter of Air Control Cover compresses.

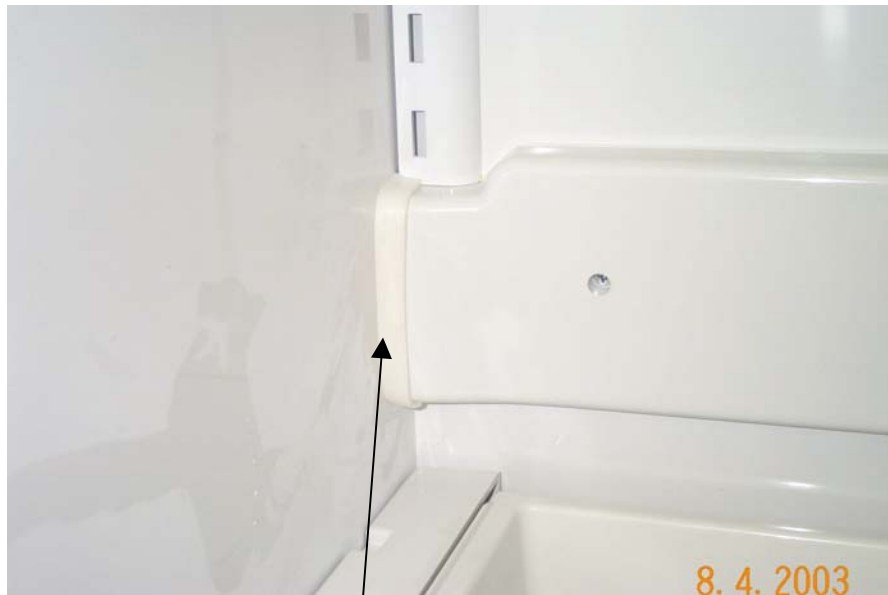
Gasket Foam-A3189348

- 7) If air is still leaking or you see a gap on the left hand side of Air Control Cover, place Gasket Foam (Gasket Foam-A3189348) around the outside perimeter of Air Control Cover (Cover-Air Control-12231201)

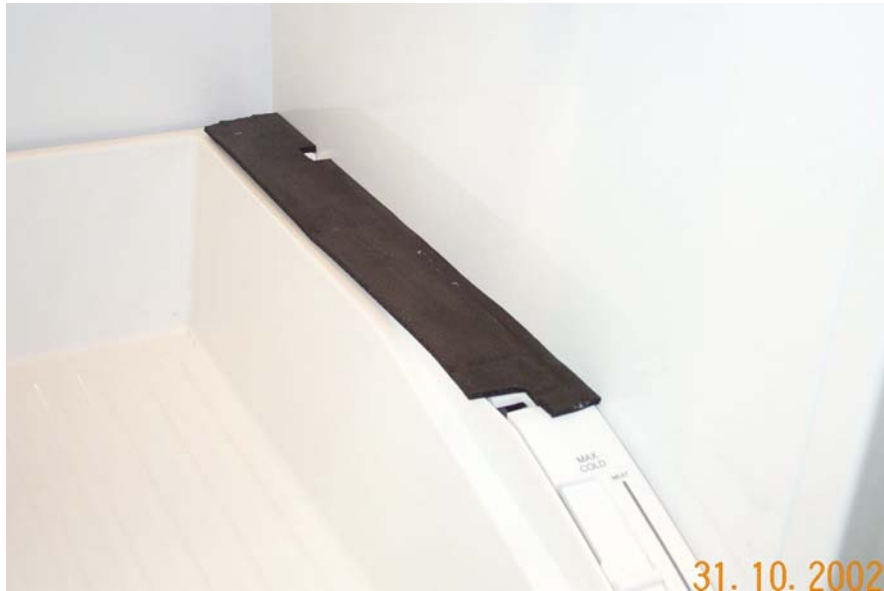
Right Hand Side

(PLEASE NOTE: Service Fix will have white gaskets)
