Front Service Washer Updates

HOME LAUNDRY HL3-96
LOUISVILLE BUILT "T" MODEL-
HOTPOINT, GE, RCA WASHERS.
LOWER HARNESS KIT

HOME LAUNDRY HL4-96
LOUISVILLE BUILT "T" MODEL-
HOTPOINT, GE, RCA WASHERS.
BLEACH FUNNEL KINKED
March 8, 1996

**HOME LAUNDRY HL5-96
LOUISVILLE BUILT "T" MODEL-
HOTPOINT, GE, RCA WASHERS.
WATER VALVE NOISE**

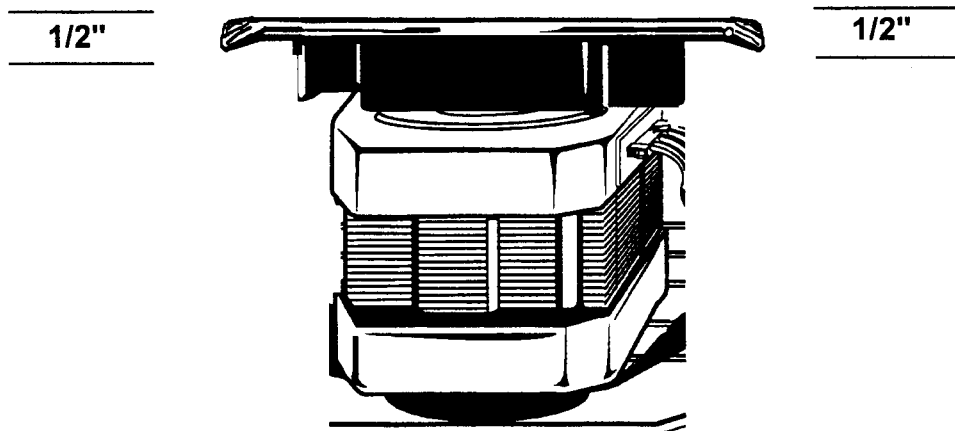
BEND CORNERS OF MOTOR SHIELD DOWN ABOUT 1/2"

On some full sized GE, Hotpoint, RCA, and Profile washers the hose on the bleach funnel to the air vent bottle can be kinked when installed at the factory. To eliminate the kink, remove the front panel from the machine, disconnect the hose from the funnel, cut off approximately 1/2" of the hose, reposition the air vent bottle and the hose to eliminate the kink. Caution the customer to only pour bleach into the funnel as fast as the system will allow. Do not pour fast enough to cause the funnel to overflow. Before reinstalling the front panel, bend the outside corners of the motor shield down 1/2" according to illustration below.

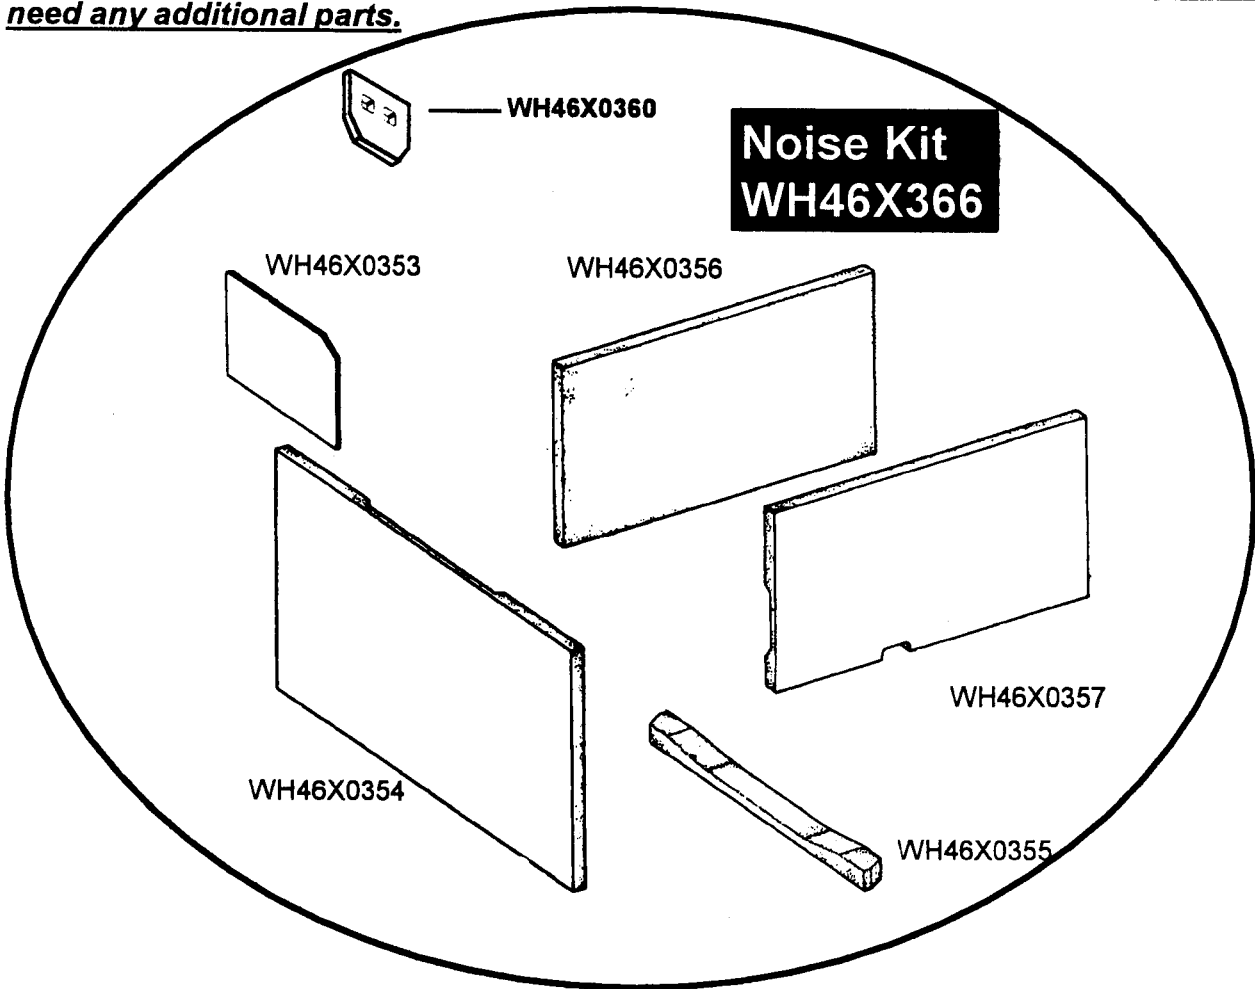
FOAM PLACEMENT LOCATION ON BACKSIDE THIS BULLETIN

Noise problems described above can be reduced by installation of the foam kit shown below. All of the pieces are self-adhesive, and should be installed per the illustrations on this bulletin.

It will be easier to install the side panels if the backing paper is not completely removed during installation. Leave a strip of paper approximately 2" wide on the bottom of the panel. This strip will make it easier to slide the foam into place and attach to the side of the cabinet. **Profile- models have the noise package installed in the factory, and do not need any additional parts.**

FRONT PANEL PLACEMENT (Kit WH46X366)

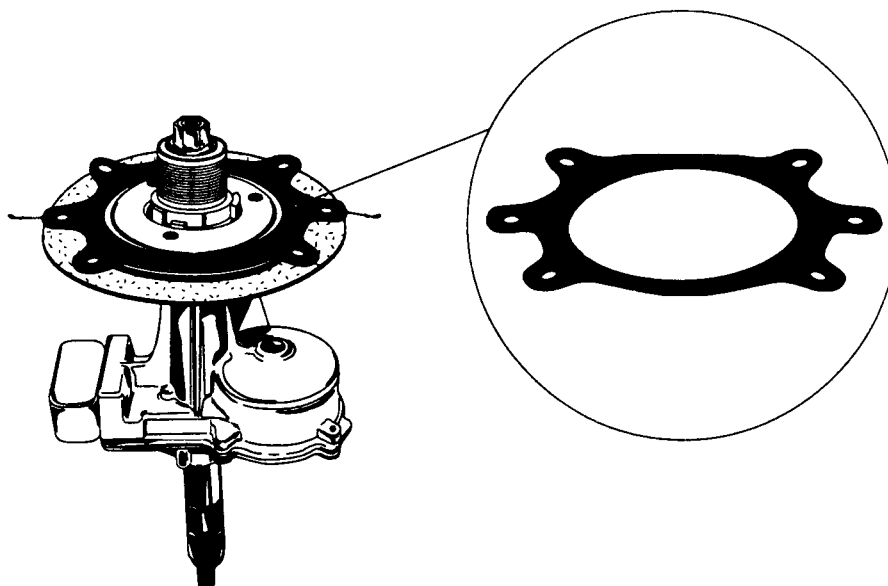
Transmission Brake System Replacement Instructions
Kit Number WH38X10002

Customer complaints of transmission noise, oil leaks, or being locked up on GE, Hotpoint, and RCA full-sized washers can be solved using a transmission with a newly designed brake system. The transmission part number is WH38X10002.

1. Remove the tub/drive assembly from the washing machine.
2. Remove the spin basket from the tub and transmission (same as today).
3. Flip the tub/drive assembly over.

14. Flip the tub/drive assembly and reassemble the basket (same as today).
15. Reassemble the tub/drive assembly into place (same as today).
16. Test the brake by spinning and stopping the machine to insure brake is performing. Check several times to allow brake to initially wear in. Basket should stop in approx. 2 seconds.

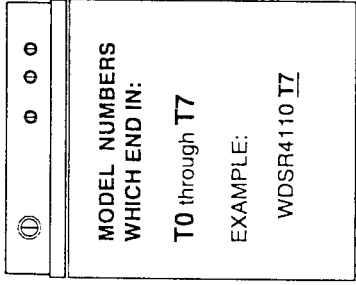
**ONLY WH38X55
TRANSMISSIONS**

WH38X55
WILL ACCEPT
BEARING KIT

**ONLY T ZERO - T7
MODELS HAVE
WH38X55
TRANSMISSIONS**

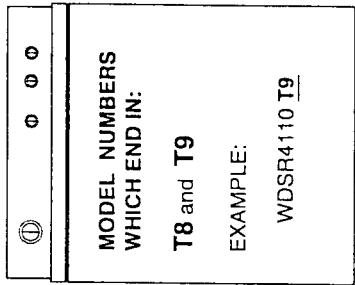
WH38X10001
WILL NOT ACCEPT
BEARING KIT

This transmission can only be used in model series #1 and #2.

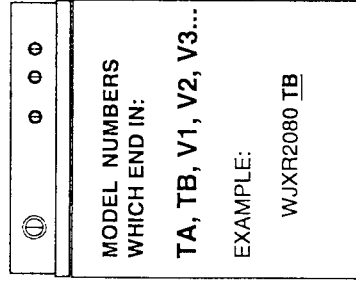
WH38X10002
WILL NOT ACCEPT
BEARING KIT

This transmission can be used in **ALL** T-line series washers (model series 1, 2 & 3)
