SERVICE NOTE BOOK
ALL REFRIGERATOR MODELS
VUAR--VRBD--VUBD--VUWC

VIKING RANGE ALL-REFRIGERATION MODELS

VUWC140/150—VUAR140/150—VRBD—VUBD

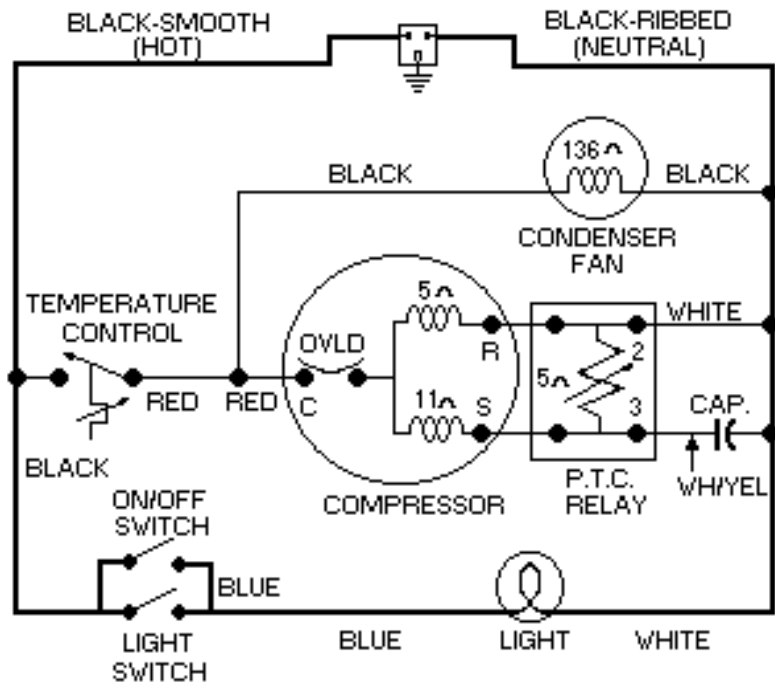
WIRING DIAGRAM VUAR—VUWC

- Light bulb is intermediate 15 watt bulb. DO NOT use a higher wattage bulb.
- Optional item.

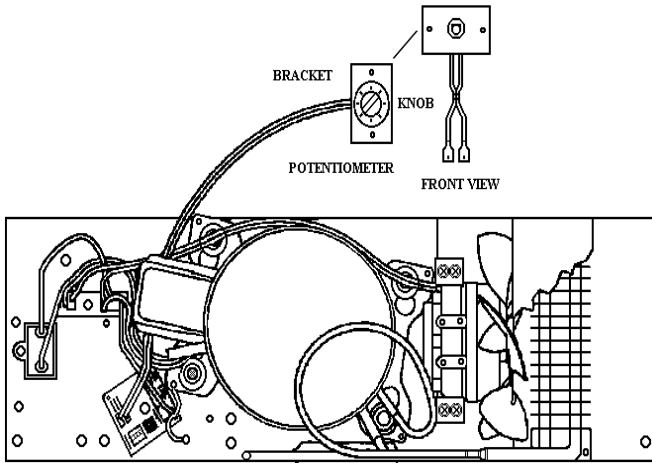
9. Mount control on base plate in location

9. Mount control on base plate in location shown in the supplied drawing.
10. Plug in molded connector from the power cord to control (match up according to the color of the wires).
11. Install neutral wire to control.
